March 19, 2021

**Supplemental Report of Geotechnical Exploration and Slope Stability Analyses
Allen Street Slope Failure – South Section
Sylva, North Carolina
KEG Project No. JA20-4021-02**

March 19, 2021
KEG Project No. JA20-4021-02

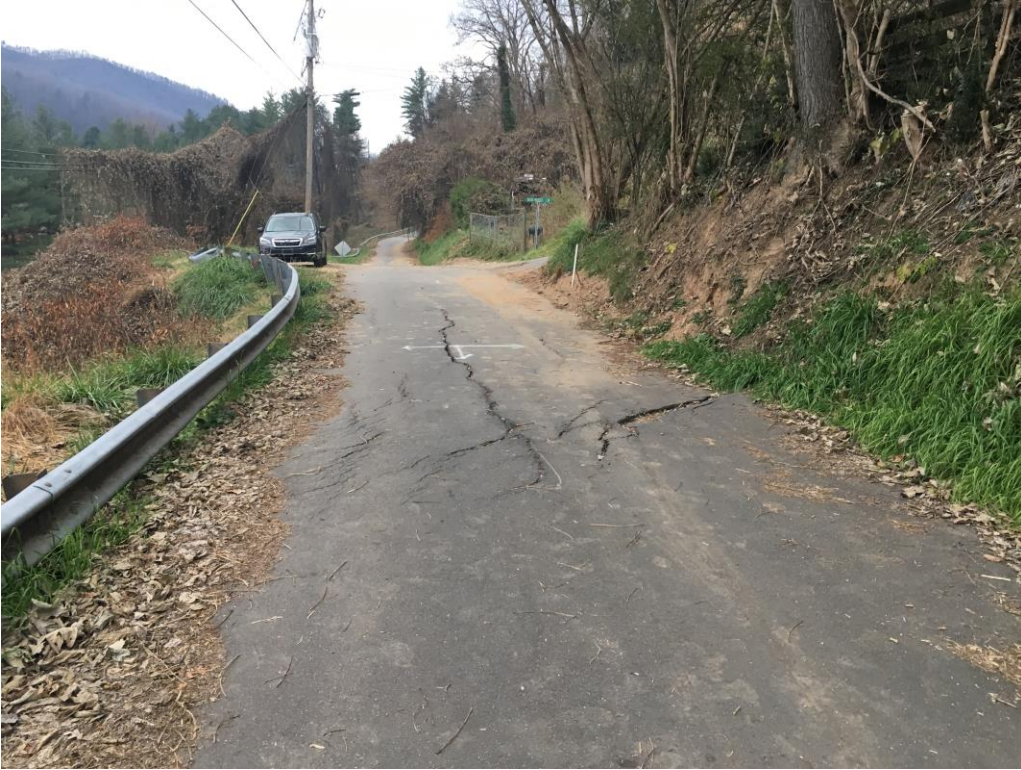
Photo 1: Tension cracking within Allen Street, approx. 30 feet NE of Bobwhite Lane, vicinity of B-11, photo facing southwest. Photo dated 11/25/2020.

Based on our analyses of the slope cross-sections at the observed tension cracking in Allen Street, it is our opinion that the current tension cracking observed approximately 30 feet northeast of Bobwhite Lane (reference Photo 1) and approximately 180 feet southwest of Bobwhite Lane (reference Photo 2) is at this time due to localized instability within the fill slope. Slope stability analyses at these areas indicate a factor of safety $FS \approx 1.0$, indicative of failure or near-failure. It is our experience that unreinforced, permanent fill slopes (such as those supporting Allen Street in these areas) that are benched into a suitable foundation and adequately compacted should be constructed at 2H:1V slope configurations, or flatter, in order to maintain long-term stability and to have an industry standard factor of safety with respect to global slope stability. The existing fill slopes in these areas have inclinations as steep as 1.3H:1V to 1.8H:1V.

It is therefore our opinion that localized repair of these fill slopes should likely include incorporation of the soil nail / ground anchor system previously recommended in our aforementioned *Report*. Soil nails are used to create a mass of soil which then behaves as a gravity system to resist lateral earth pressures. The soil nail system should take the global stability of the site and potential traffic loading into account. Soil nailing will have the advantage of being able to be constructed without removing large sections of the existing roadway; however, care must be taken to avoid existing utilities during installation thereof. Easements may be required where soil nails extend beyond adjacent property lines.

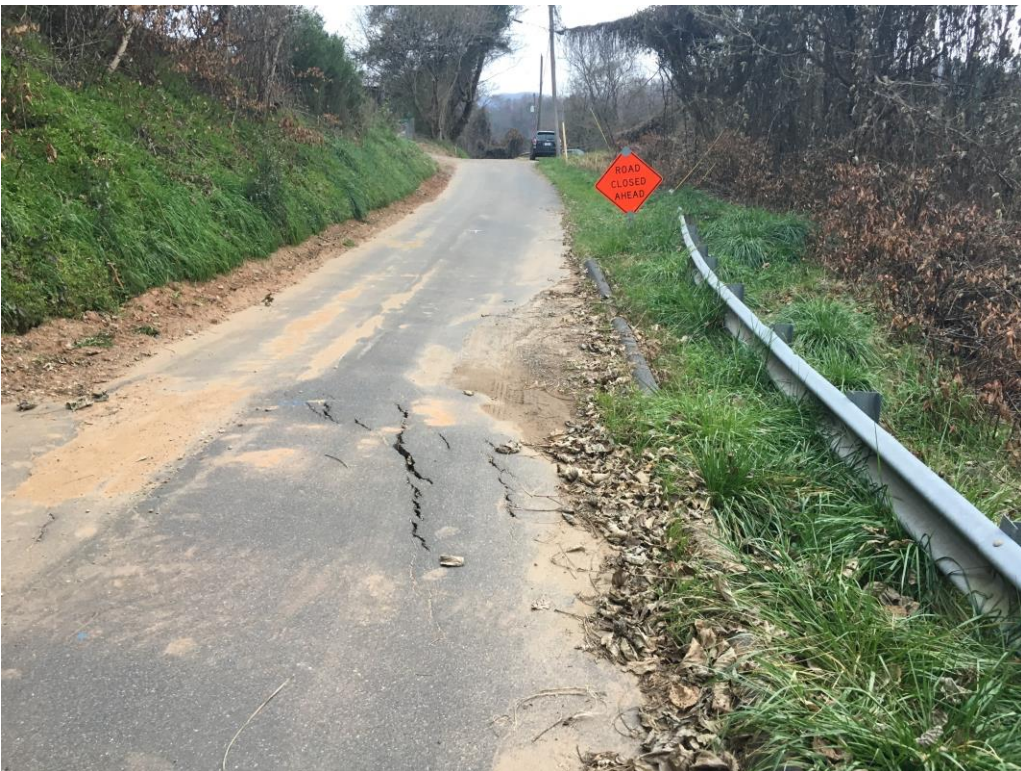
Photo 2: Tension cracking within Allen Street, approx. 180 feet SW of Bobwhite Lane, vicinity of B-14, photo facing northeast. Photo dated 11/25/2020.

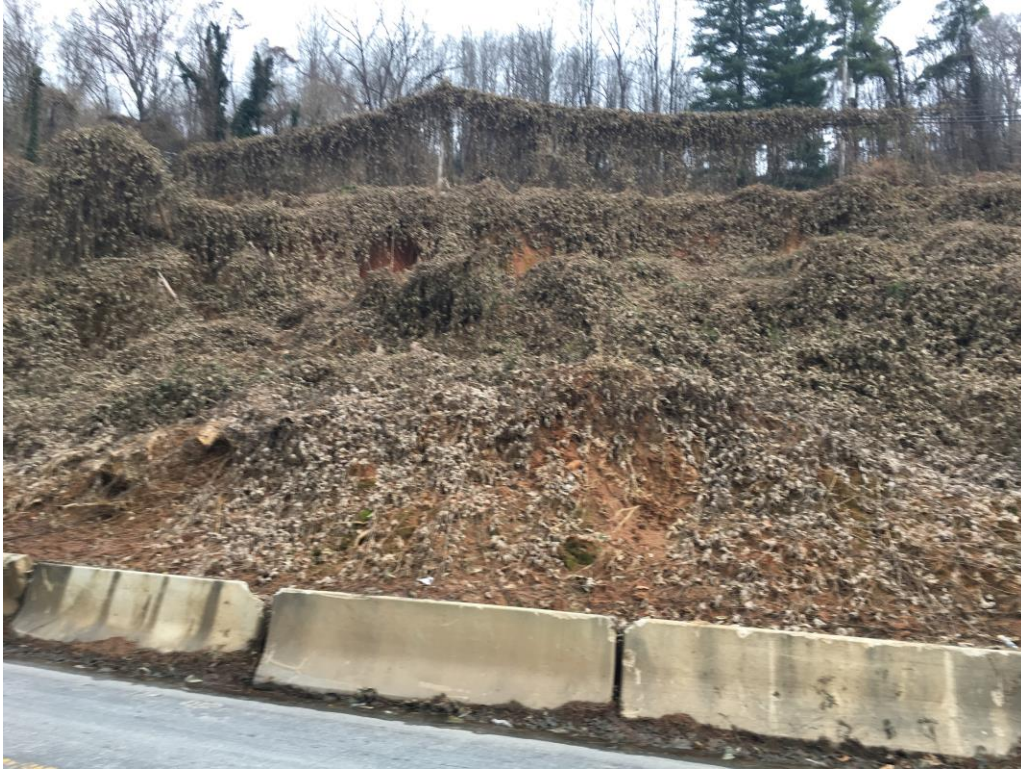
Photo 3: Base of adjacent property failure area, viewed from Chipper Curve Road, photo facing northwest. Photo dated 11/25/2020.

Subsurface exploration of the adjacent property failure area bounded by Allen Street and Chipper Curve Road was beyond the scope of this report; however, borings located roughly uphill of the main scarp location (B-11, B-12/12-A, and B-13) encountered loose residual soils to depths of approximately 27 to 37 feet in this area, with groundwater measurements ranging from approximately 20 to 30 feet deep. It is likely that similar subsurface conditions are present within the adjacent property failure area, and that the failure has been initiated by a combination of high groundwater and a relatively thick strata of weaker residual soils.

An expansion of the existing failure in this general area could negatively impact the future serviceability of Allen Street. Soil nailing or ground anchor systems described above to stabilize the existing fill slopes will not improve the stability of the adjacent property failure area. Additionally, these systems will not function as intended and could be compromised if the adjacent property slope failure expands significantly uphill. Remedial measures will be required to permanently stabilize the adjacent property failure area. This could likely include some combination of 1.) dewatering the failure area with horizontal drains, 2.) regrading of the property to a shallower overall slope inclination to remove excess driving force, and 3.) the possible installation of soil nail / ground anchor systems. Detailed remedial recommendations should be developed in conjunction with a subsurface investigation and additional analyses of the adjacent property.
