July 14, 2020

**Report of Geotechnical Exploration and Slope Stability Analyses
Allen Street – Slope Failure
Sylva, North Carolina
KEG Project No. JA20-4021-01**

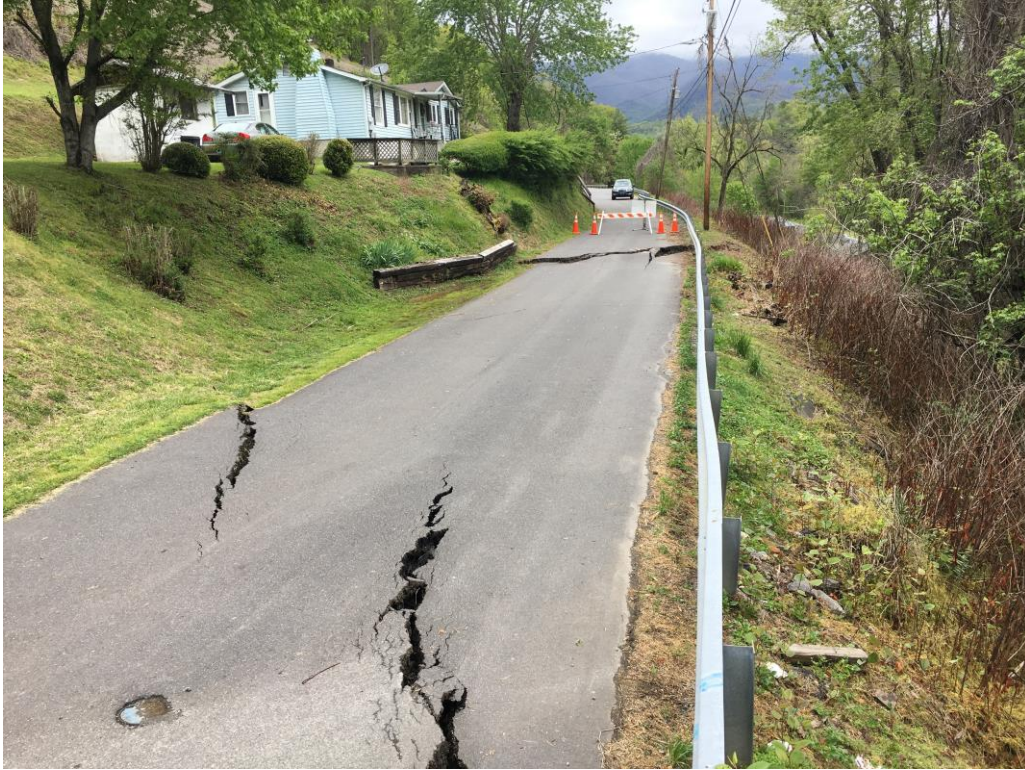
The subject slope failure formed in late April, 2020 after a heavy precipitation event. The slope failure initialized with tension cracking within Allen Street near/adjacent the residential property at 527 Allen Street (see Photo 1). A bowl-shaped series of tension crack formed through the roadway pavements, was approximately 100 to 110 feet wide within Allen Street, and exhibited vertical displacements (scarps) on the order of 8 to 12 inches at the time of our site visit. Shallow ponded water was observed in the grassed shoulder area near the rear/west of the tension cracks. The lower bound of the slope failure area extended to the driveway access area at Bryson Park located off Chipper Curve Road. Minor knuckling of a portion of the driveway asphalt was observed during this site visit, and water seepage was also observed exiting the toe of the slope (see Photo 2). The grassed area to the south of the Bryson Park driveway was also wet with water seepage.

Photo 1: Slope Failure Area observed within Allen Street, facing north. Photo dated 04/30/2020.

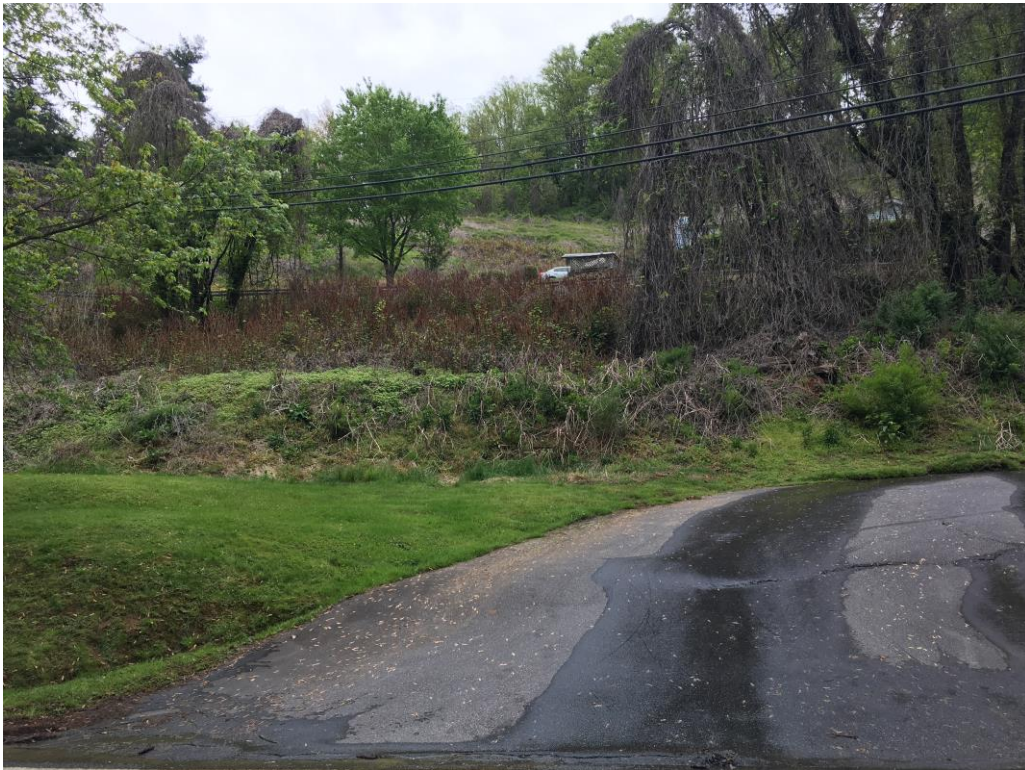
Photo 2: Slope Failure Area observed from Chipper Curve Road, facing west. Photo dated 04/30/2020.

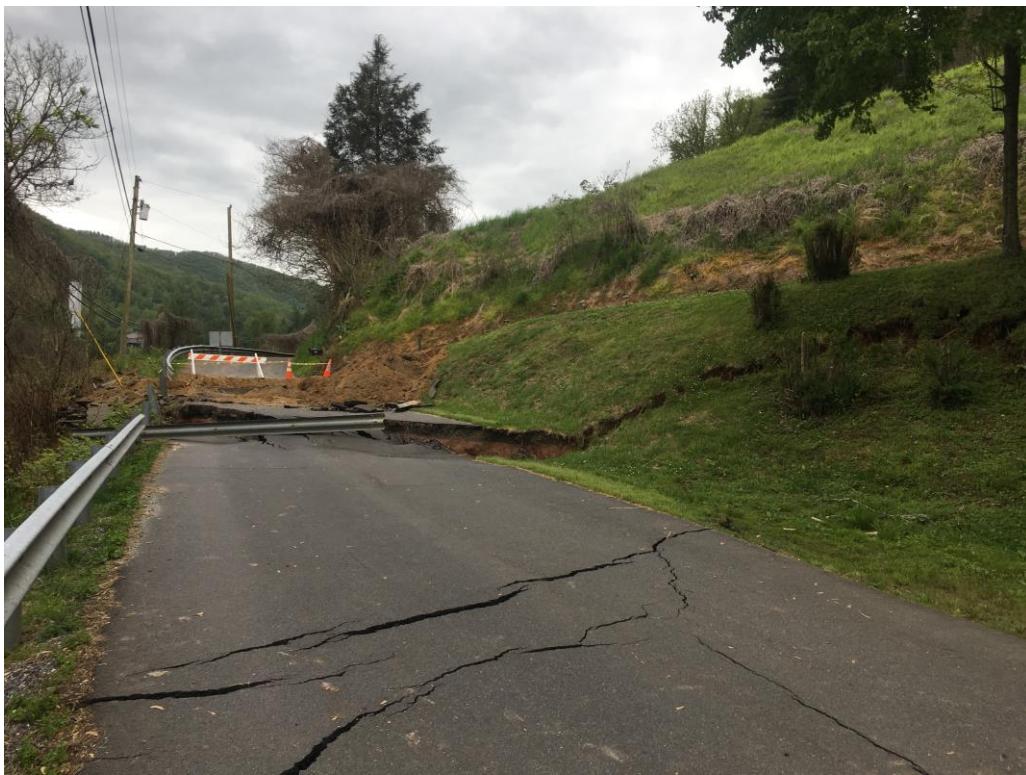
Additional movement of the failure zone took place between our April 30, 2020 and May 5, 2020 site visits. This movement included additional cracking of the asphalt in Allen Street (see Photo 3) as well as dropping of the failure zone to a total scarp height of approximately 2 feet (see Photo 4). The tension crack extended up the fill slope supporting the driveway for the residential property at 527 Allen Street (see Photo 5). During our site visit, we also observed significant water flowing (several gallons per minute) out of a shallow excavation near the north end of the failure area within Allen Street (see Photo 6). Based on conversations with Mr. Scott, we understand this was likely the result of a rupture in the TWSA water main, and was subsequently cut off in the following days. Severe knuckling of a portion of the driveway asphalt at Bryson Park at the base of the failure area was observed during this site visit, and water seepage was also observed exiting the toe of the slope (see Photos 7, 8). The grassed area to the south of the driveway also continued to be very wet with seepage.

Photo 3: Slope Failure Area observed within Allen Street, facing south. Photo dated 05/06/2020.

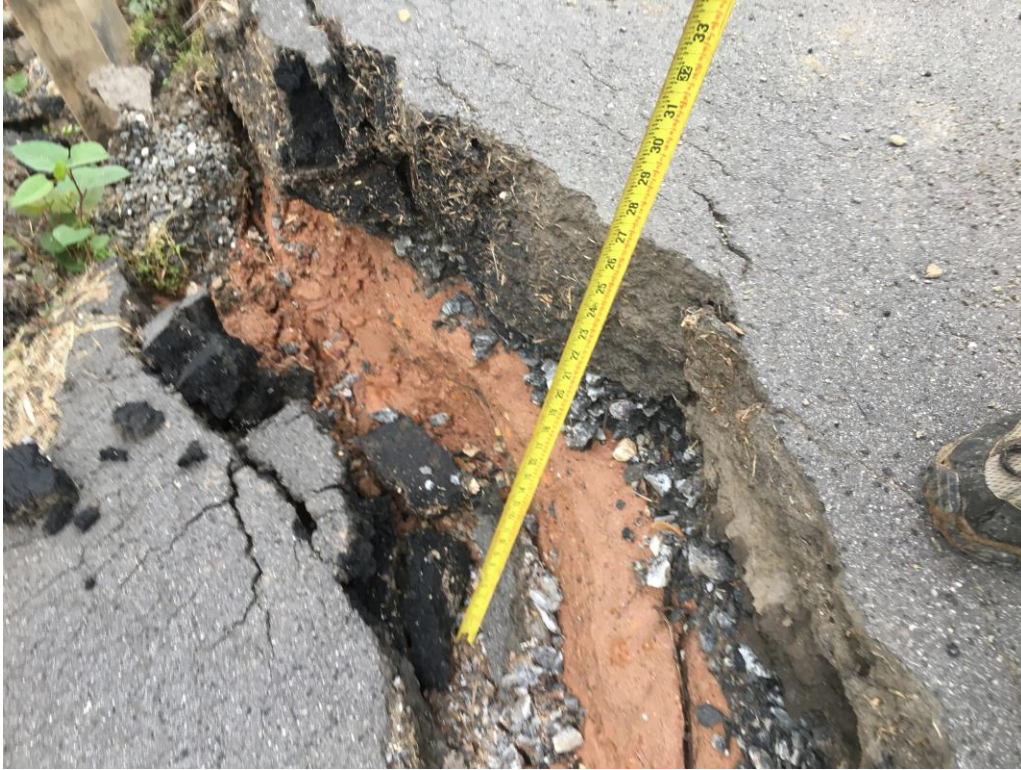
Photo 4: Approx. 2 feet vertical scarp on south edge of failure at Allen Street. Photo dated 05/06/2020.

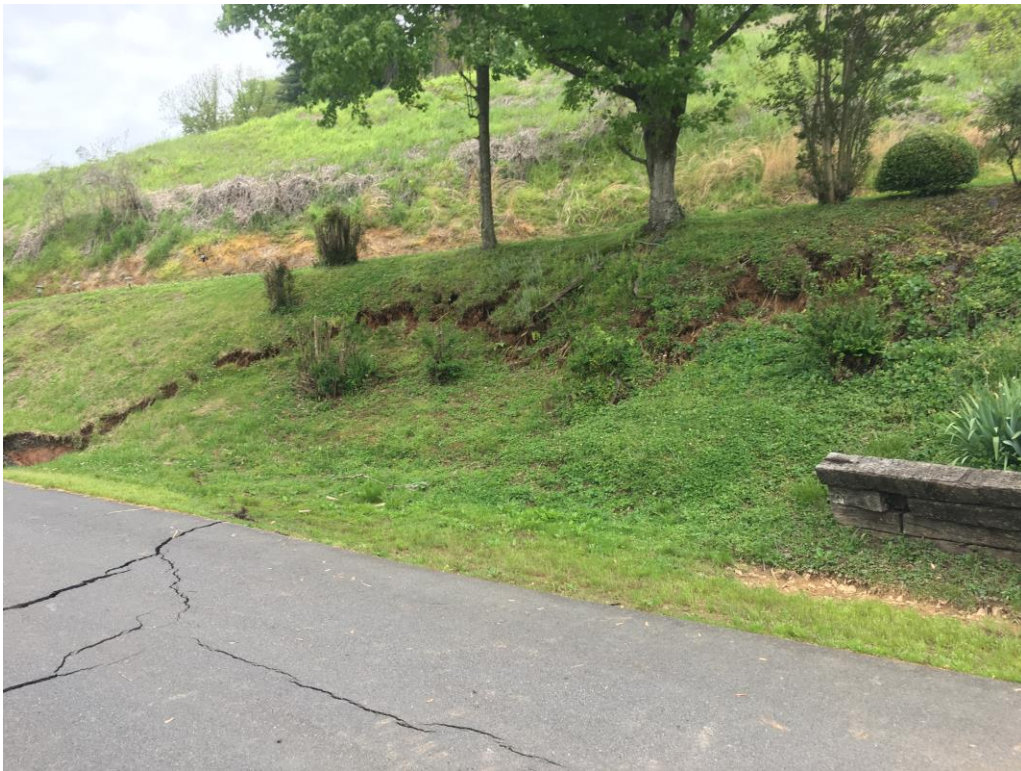
Photo 5: Extension of tension cracking up adjacent slope at 527 Allen Street. Photo dated 05/06/2020.

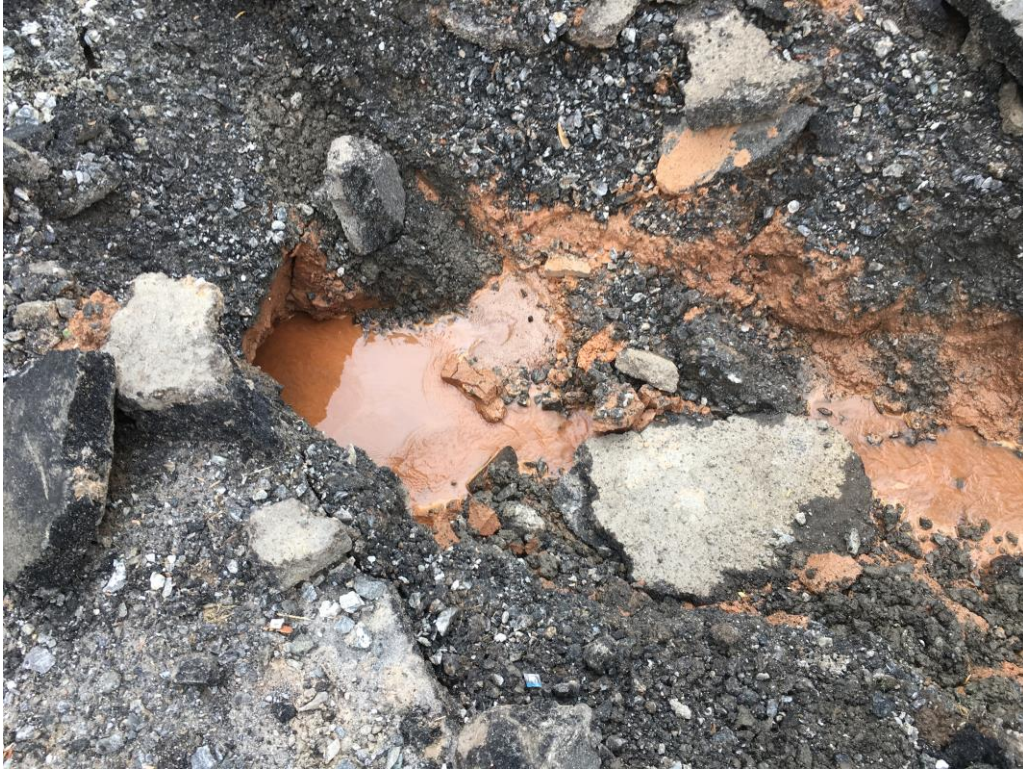
Photo 6: Water flowing near north end of failure within Allen Street. Photo dated 05/06/2020.

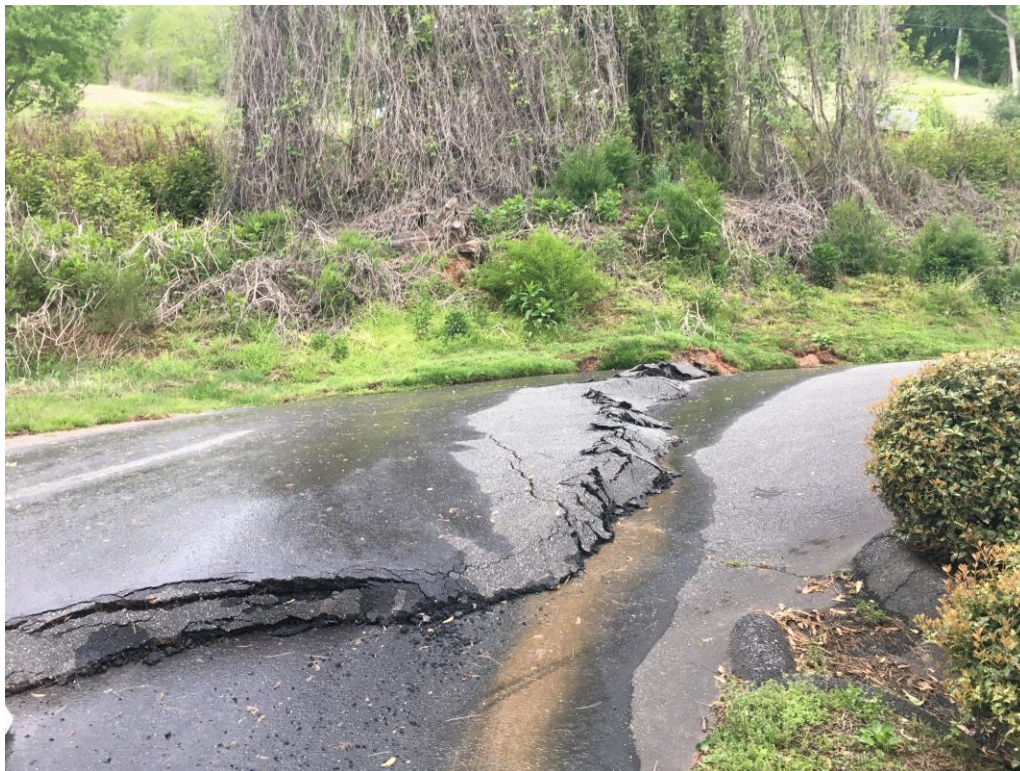
Photo 7: Slope Failure Area observed at Bryson Park entrance, facing west. Photo dated 05/06/2020.

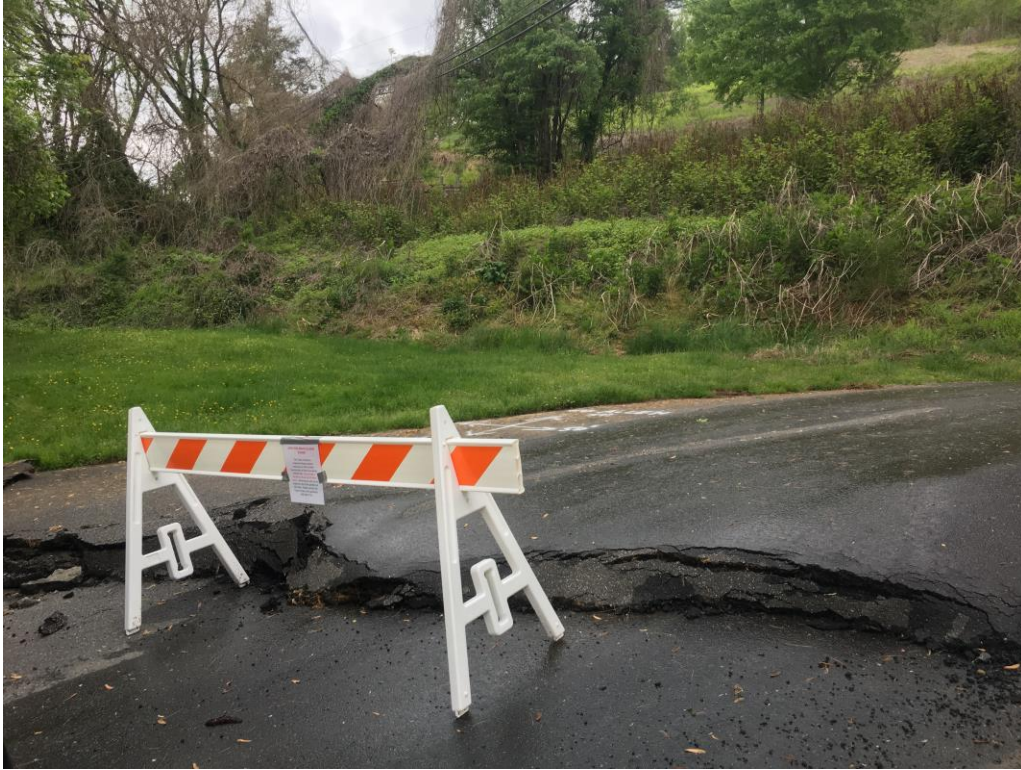
Photo 8: Slope Failure Area observed at Bryson Park entrance, facing west. Photo dated 05/06/2020.

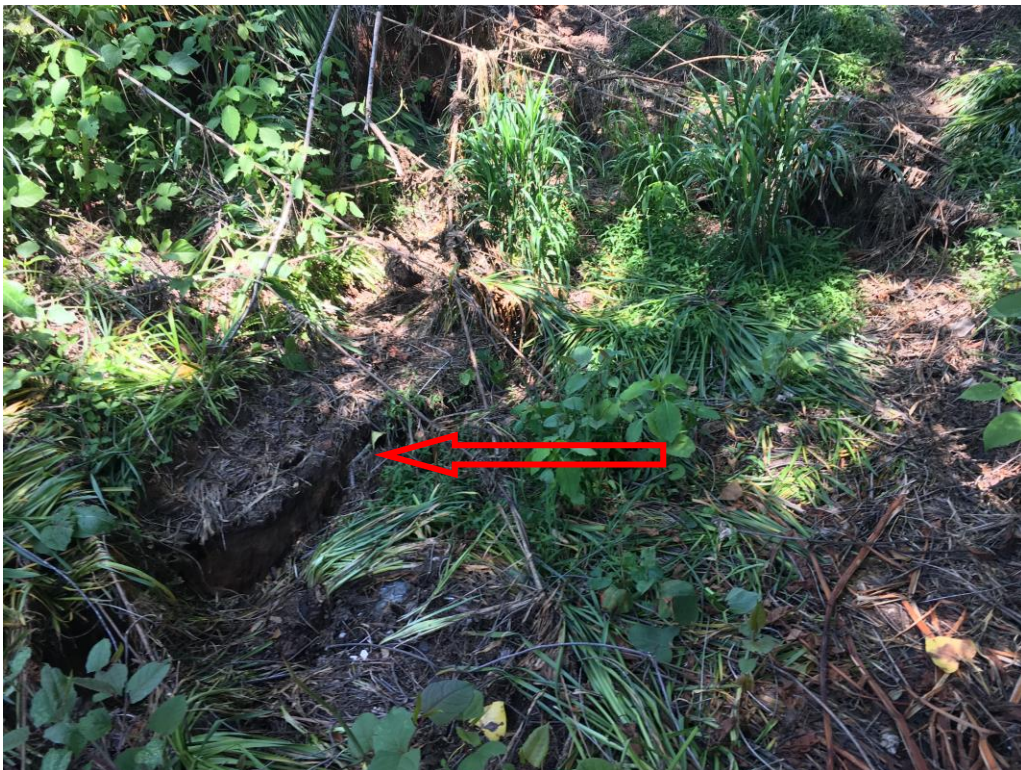
A tension crack was observed along the north end of the failure zone within the mid-slope bench (see Photo 9). Additional significant movement of the failure area was not observed during this site visit, and the surface of the pavement at the base of the failure at the Bryson Park driveway was essentially dry.

Photo 9: Tension crack observed within mid-slope bench, north end of failure. Photo dated 05/10/2020.
