Field Report

Allen Street Slope Failures Sylva, North Carolina

November 2, 2020

North Carolina Geological Survey

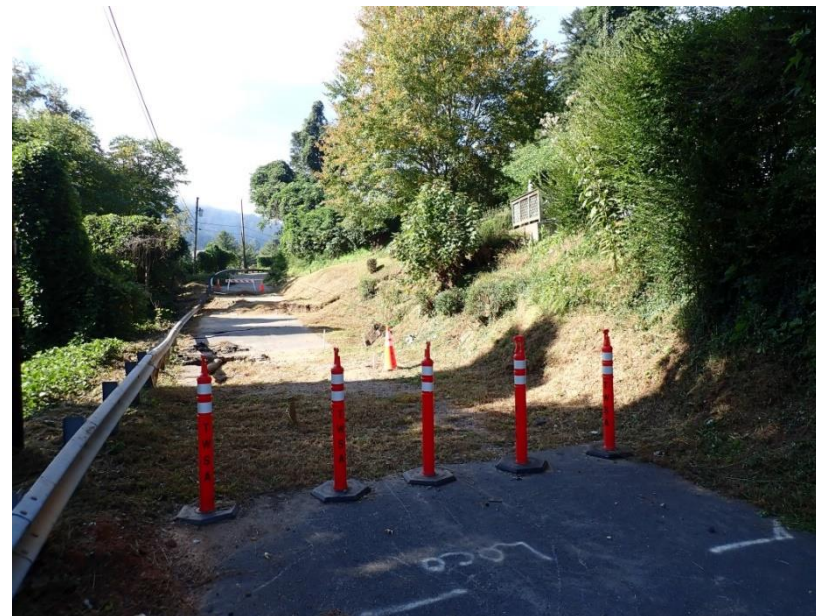
Our observations of the slide extent and characteristics, and geologic materials exposed at the surface are generally consistent with those presented in the KEG report (Kessel and Johnson, 2020). Figure 5 illustrates slide conditions as observed during our investigation. Figure 5A shows the down-dropped section of Allen Street, now barricaded. The upper portion of the main slide scarp extends into private property at 527 Allen Street (Fig. 5B) and threatens the driveway. Bulging, buckling, and deterioration of the pavement at the Bryson Park entrance (Fig. 5C) appears to have progressed somewhat from that shown in the KEG report. In summary, the areal extent of slide activity and the relative amounts of displacement we observed do not appear to be greatly different than those described in the KEG report.

Figure 5A. Location A on map. Photograph showing down-dropped section of Allen Street. View looking southwest. 10/08/2020 NCGS photo.

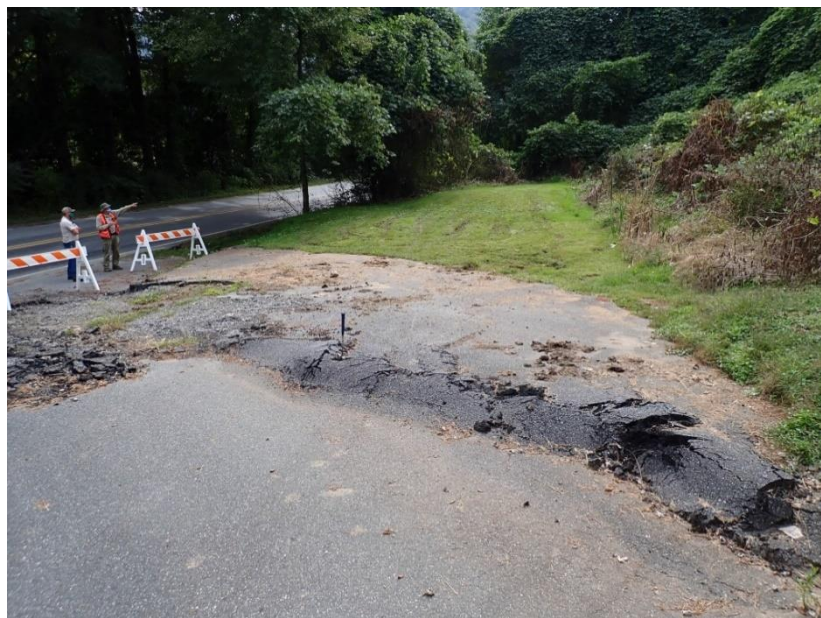
Figure 5C. Location C on map. Bulge in pavement from slide movement, Bryson Park entrance road. Ground bulging and wet ground was observed in the grassed area of the Park in the background. View looking southwest 10/08/2020 NCGS photo.

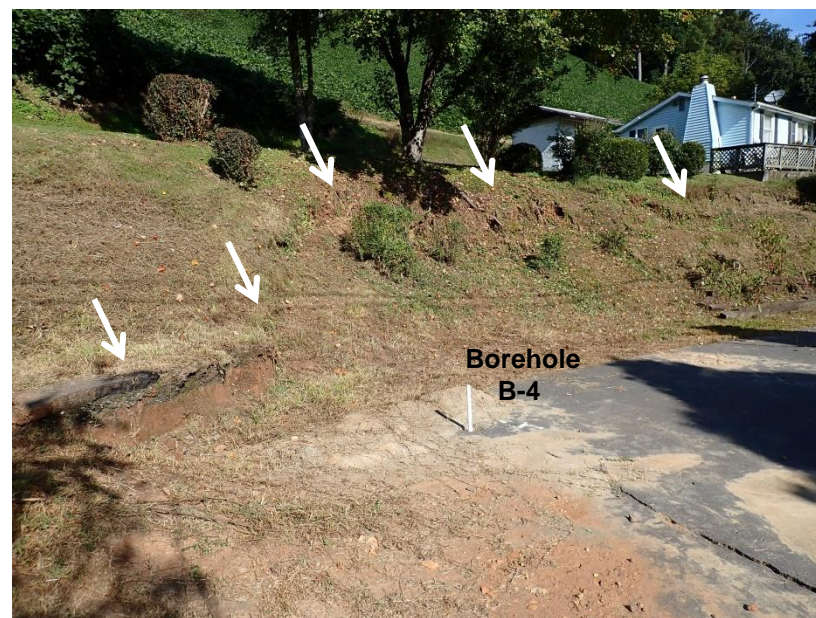
Figure 5B. Location B map. Arrows point to ground rupture (scarp) affecting Allen Street and private property upslope, and KEG borehole B-4. View looking northeast 10/08/2020 NCGS photo.

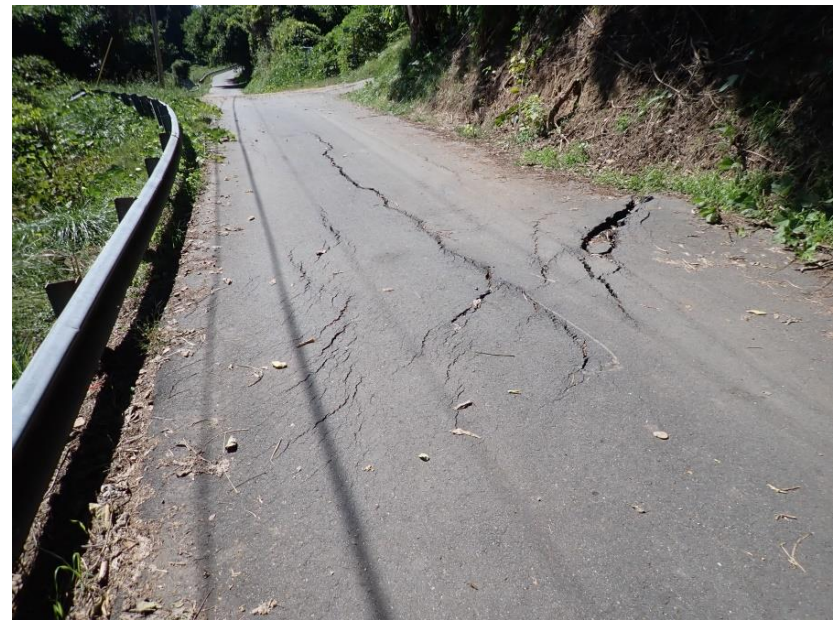
apart, and indicate initial stages of slope movement along this segment of Allen Street (Figs. 6A, C). We observed a ground rupture approximately 30-ft long, oriented SW-NE, in a vegetated slope approximately 15ft southeast of Allen Street (Fig. 6B) between the two areas of cracked pavement. The direction of slope movement indicated by these ground ruptures is generally toward the southeast. The TWSA has taken precautionary measures in anticipation of water and sewer line breaks in this section of the Allen Street corridor.

Figure 6A. Location A on map. Ground ruptures in Allen Street pavement. View looking SW. Inferred movement direction toward the SSW. 10/08/2020 NCGS photo.

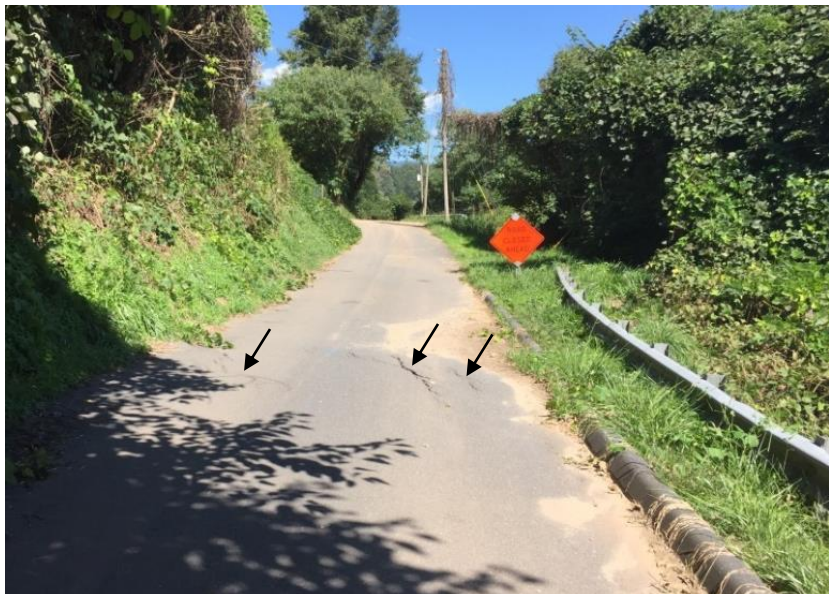
Figure 6C. Location C on map. Arrows point to ground ruptures in Allen Street pavement. Inferred movement direction toward the SE. View looking NE. 10/01/2020 NCGS photo.

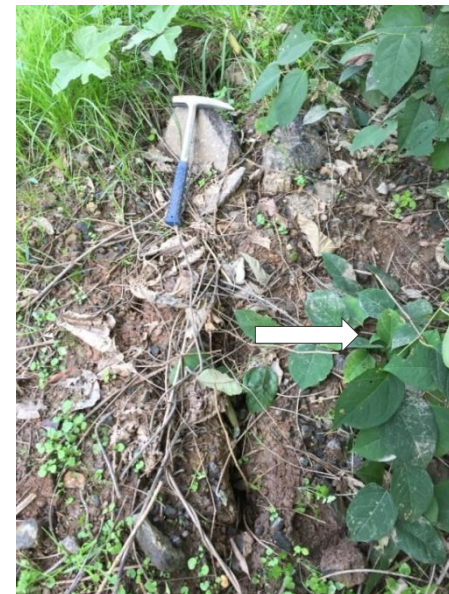
Figure 6B. Location B on map. Segment of ~30-ft long ground rupture in soil approximately 15 ft. SE of, and parallel to Allen Street. Arrow shows slope movement toward the SE. Hammer handle is ~14in long. View looking NE. 10/08/2020 NCGS photo.

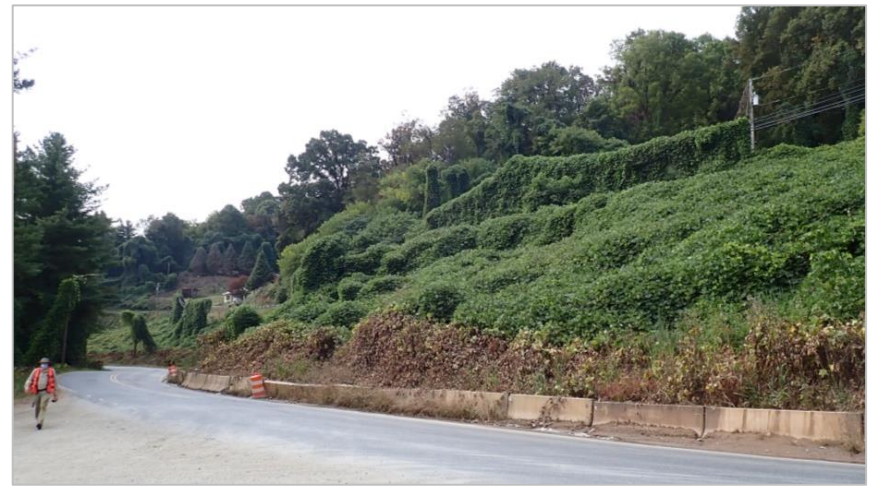
The active slide area along Chipper Curve Road is mitigated by concrete median barriers placed at the toe of the slope by NCDOT (Figs. 7A-C). Loose, wet soil has impinged on the barriers and resulted in some tipping of the barriers (Fig. 7C). A recent slide scarp is exposed midway up the kudzu-covered slope with as much as 10ft of vertical displacement (Fig. 7B,C). Completely decomposed bedrock (saprolite) is exposed in the scarp, consistent with other observations of residual soil derived from weathered bedrock in the area. Evidence indicates that this active slide area may have enlarged since 2017 with the main scarp migrating toward the northwest. Ground ruptures (scarps) and displaced soil are visible in the 2017 lidar digital elevation model for this area (Fig. 2). These coalescing slide areas predate the larger scarp observed in our ground investigations (Figs. 2 and 7B, C) and UAS imagery (Figs. 3 and 4), which is not visible in the 2017 lidar.

Figure 7A. Location A on map. Concrete median barriers at the toe of slope failure impinging on Chipper Curve Road. View looking NW. 10/08/2020 NCGS photo.

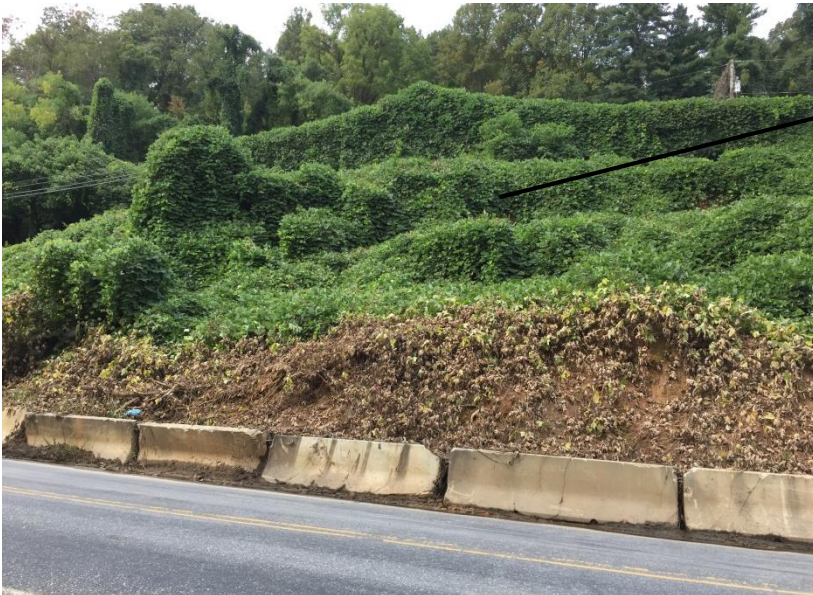
Figure 7C. Location C on map. Concrete median barriers at the toe of slope failure impinging on Chipper Curve Road in foreground. Leader line shows location of slide scarp in Fig. 7B right. View looking NW. 10/08/2020 NCGS photo.

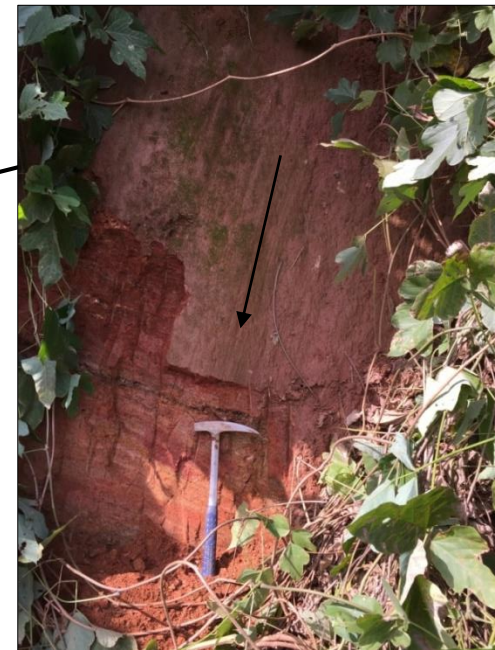
Figure 7B. Location B on map. Segment of the upper slide scarp (ground rupture) above Chipper Curve Road at location indicated in Fig. 7C. Arrow shows orientation of aligned grooves on scarp face from slide movement. Scraped section at hammer shows relict bedrock layering in completely decomposed biotite gneiss. Hammer handle is ~14in long. View looking NW. 10/08/2020 NCGS photo.
