Pinnacle Park

MASTER PLAN

Town of Sylva, Jackson County, NC

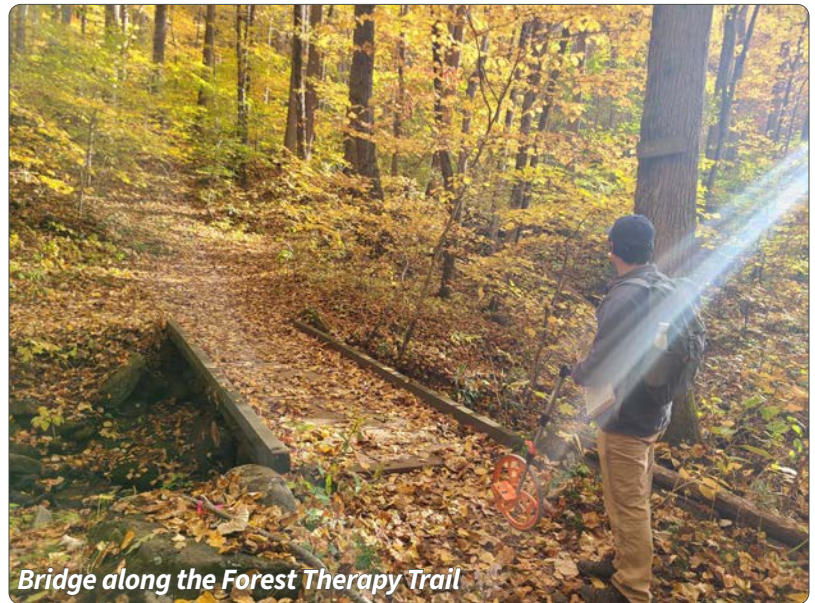
Bridge along the Forest Therapy Trail

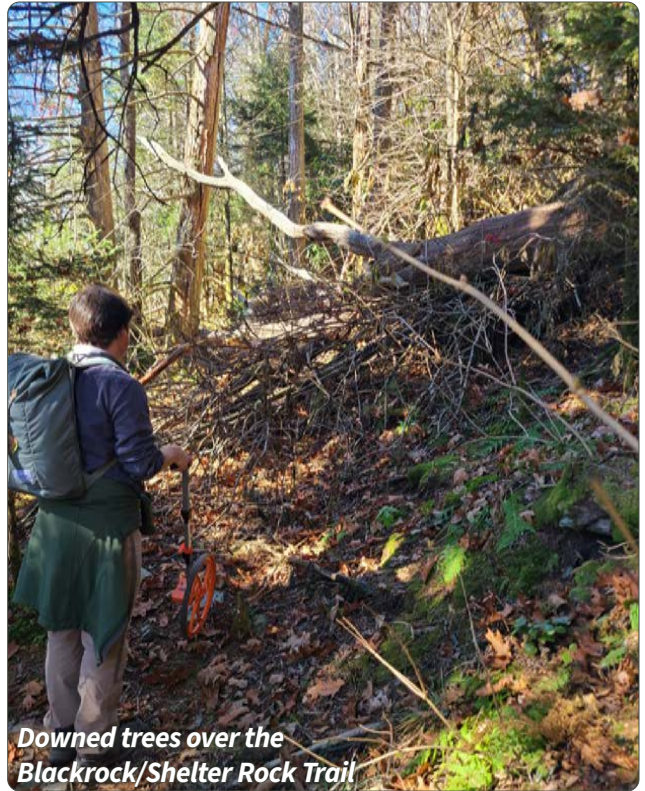
Downed trees over the Blackrock/Shelter Rock Trail

Some repair may be necessary in areas where trees have fallen across the trail. User trails should be obliterated. Steep sections may require rolling dips that occupy the road bed width or cut slope could be utilized to create grade reversals with outslope across road cut. The sections within the roadbed are generally too wide to be considered a trail. Appropriate tread width can be maintained by meandering the maintained tread within the road cut prism and allow vegetation to grow in and reduce the tread width.

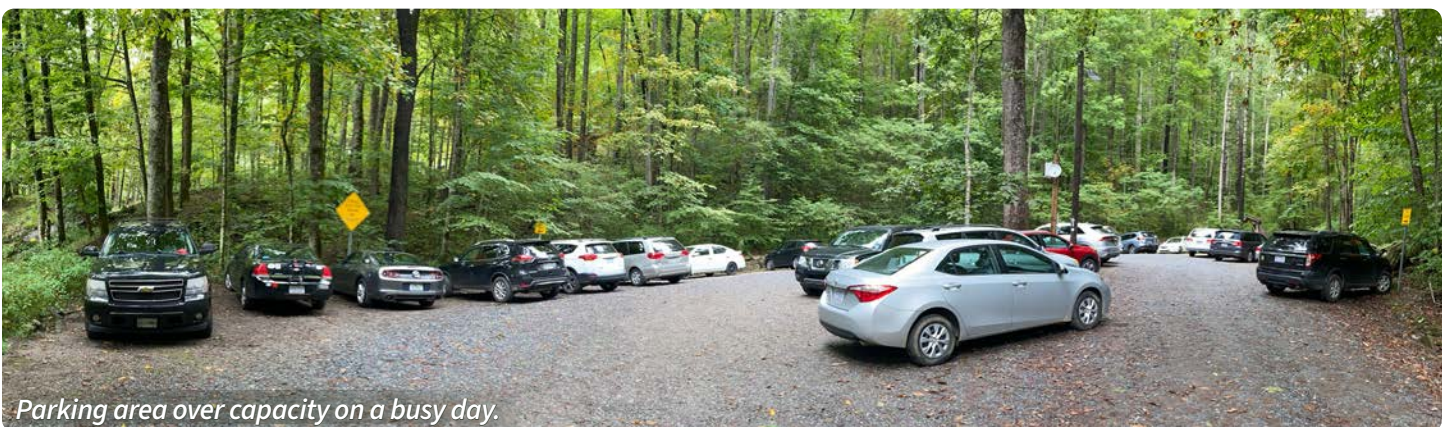
Parking area over capacity on a busy day.

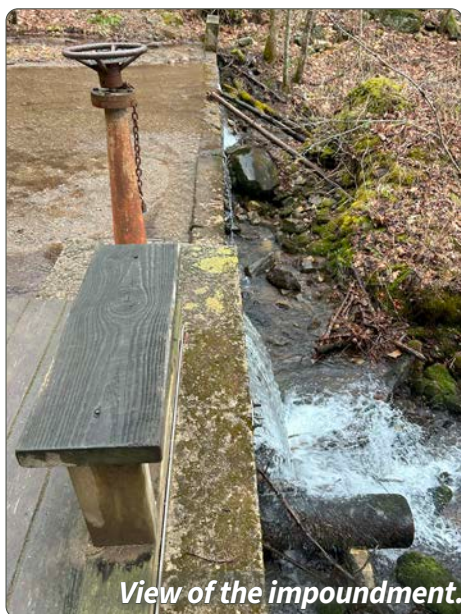
View of the impoundment.

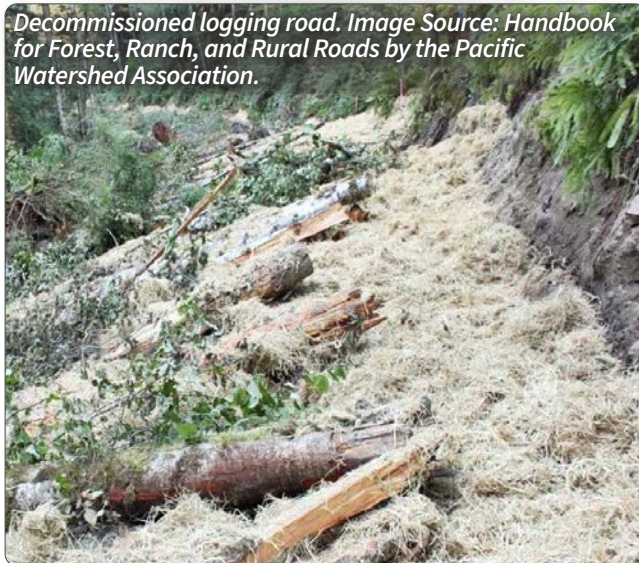
Decommissioned logging road. Image Source: Handbook for Forest, Ranch, and Rural Roads by the Pacific Watershed Association.
