March 19, 2021

**Supplemental Report of Geotechnical Exploration and Slope Stability Analyses
Allen Street Slope Failure – South Section
Sylva, North Carolina
KEG Project No. JA20-4021-02**

March 19, 2021
KEG Project No. JA20-4021-02

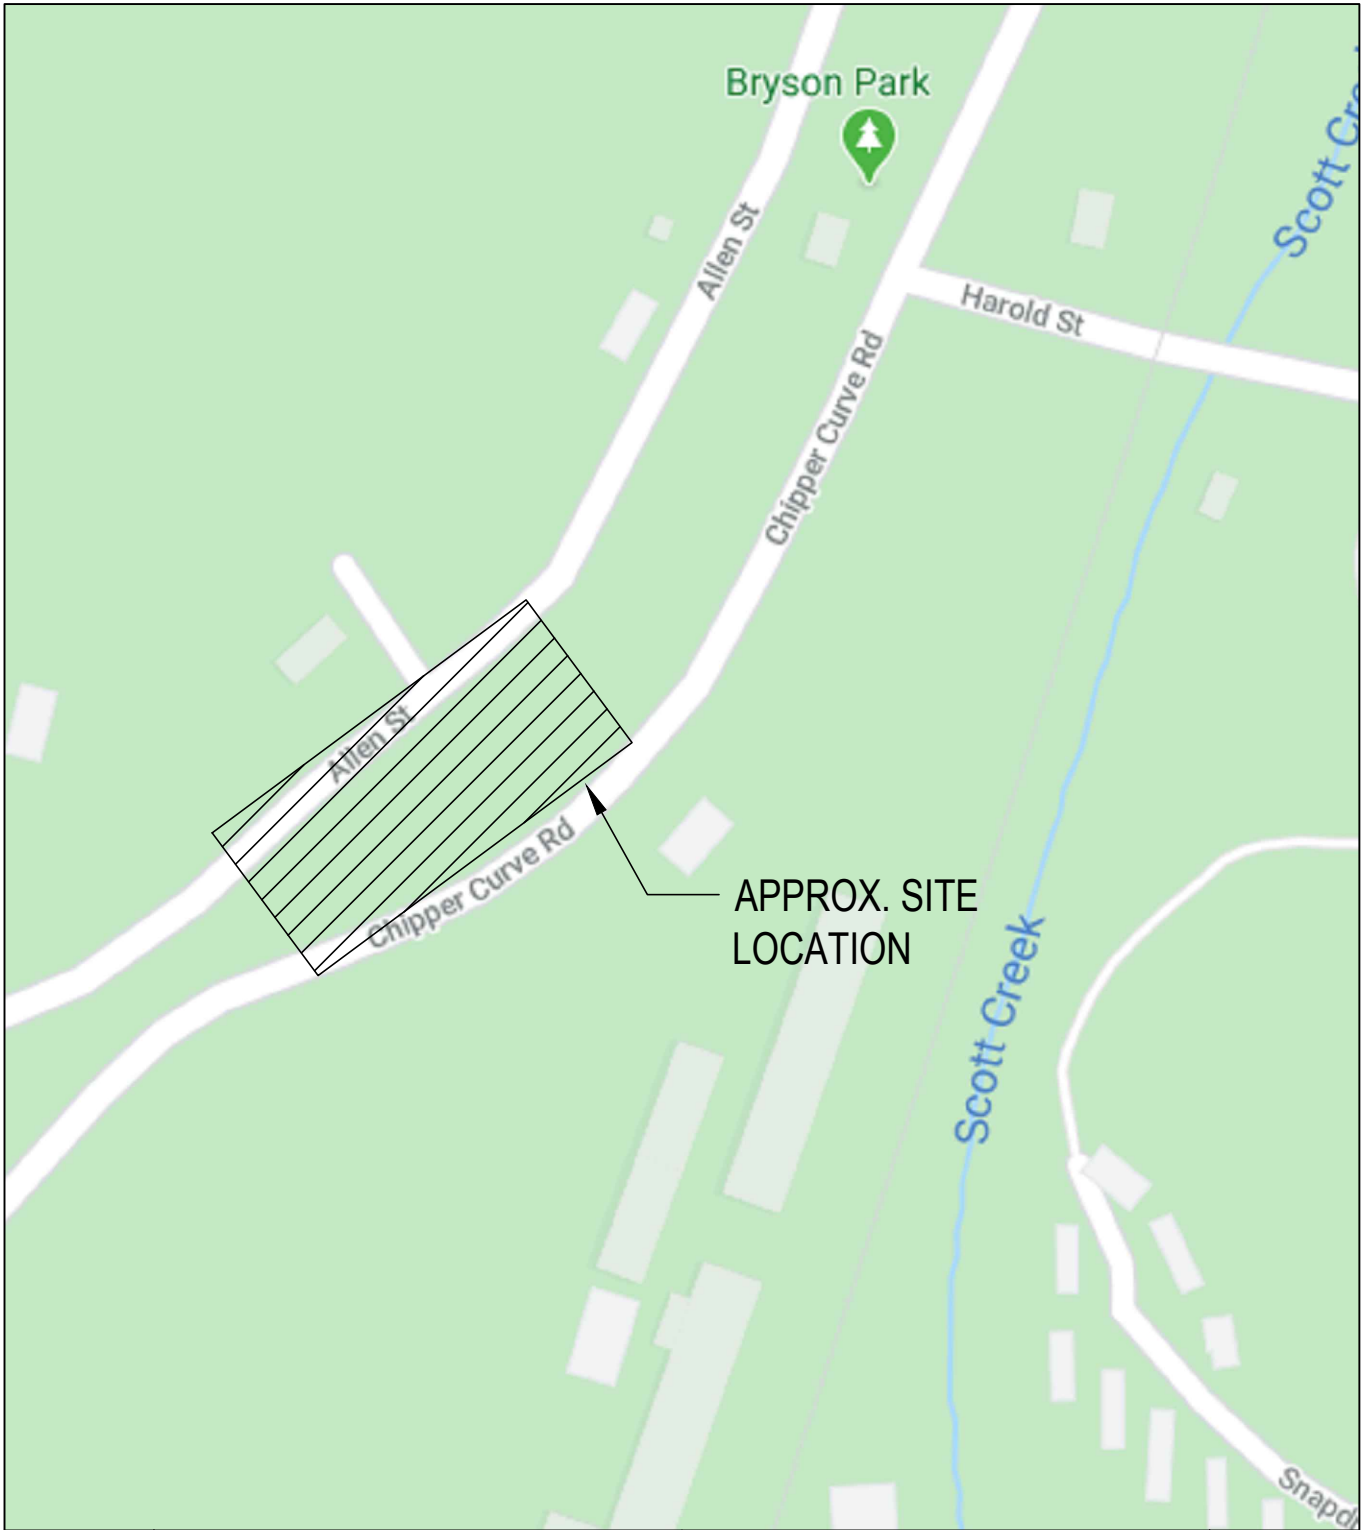
SITE LOCATION PLAN
 KEG PROJECT NO. JA20-4021-02
 DATE: 03-19-2021

The project site is located within Allen Street in Sylva, North Carolina (see Figure 1). In addition to the primary failure area documented in the aforementioned *Report*, two additional tension crack areas have formed within the Allen Street asphalt section in the second half of 2020. These two areas are located to the southwest of the primary Allen Street failure area noted above and below/southeast of the residences located at 2 Bobwhite Lane and 11 Bobwhite Lane. The tension cracks are on the order of 15 to 25 feet in length and comprised of multiple cracks forming roughly parallel to the slope face (see Photos 1, 2). Significant vertical displacements were not observed at the time of our site visits. The fill slopes supporting Allen Street in these areas are on the order of 6 to 10 feet high and have inclinations varying from approximately 1.3H:1V to 1.8H:1V.

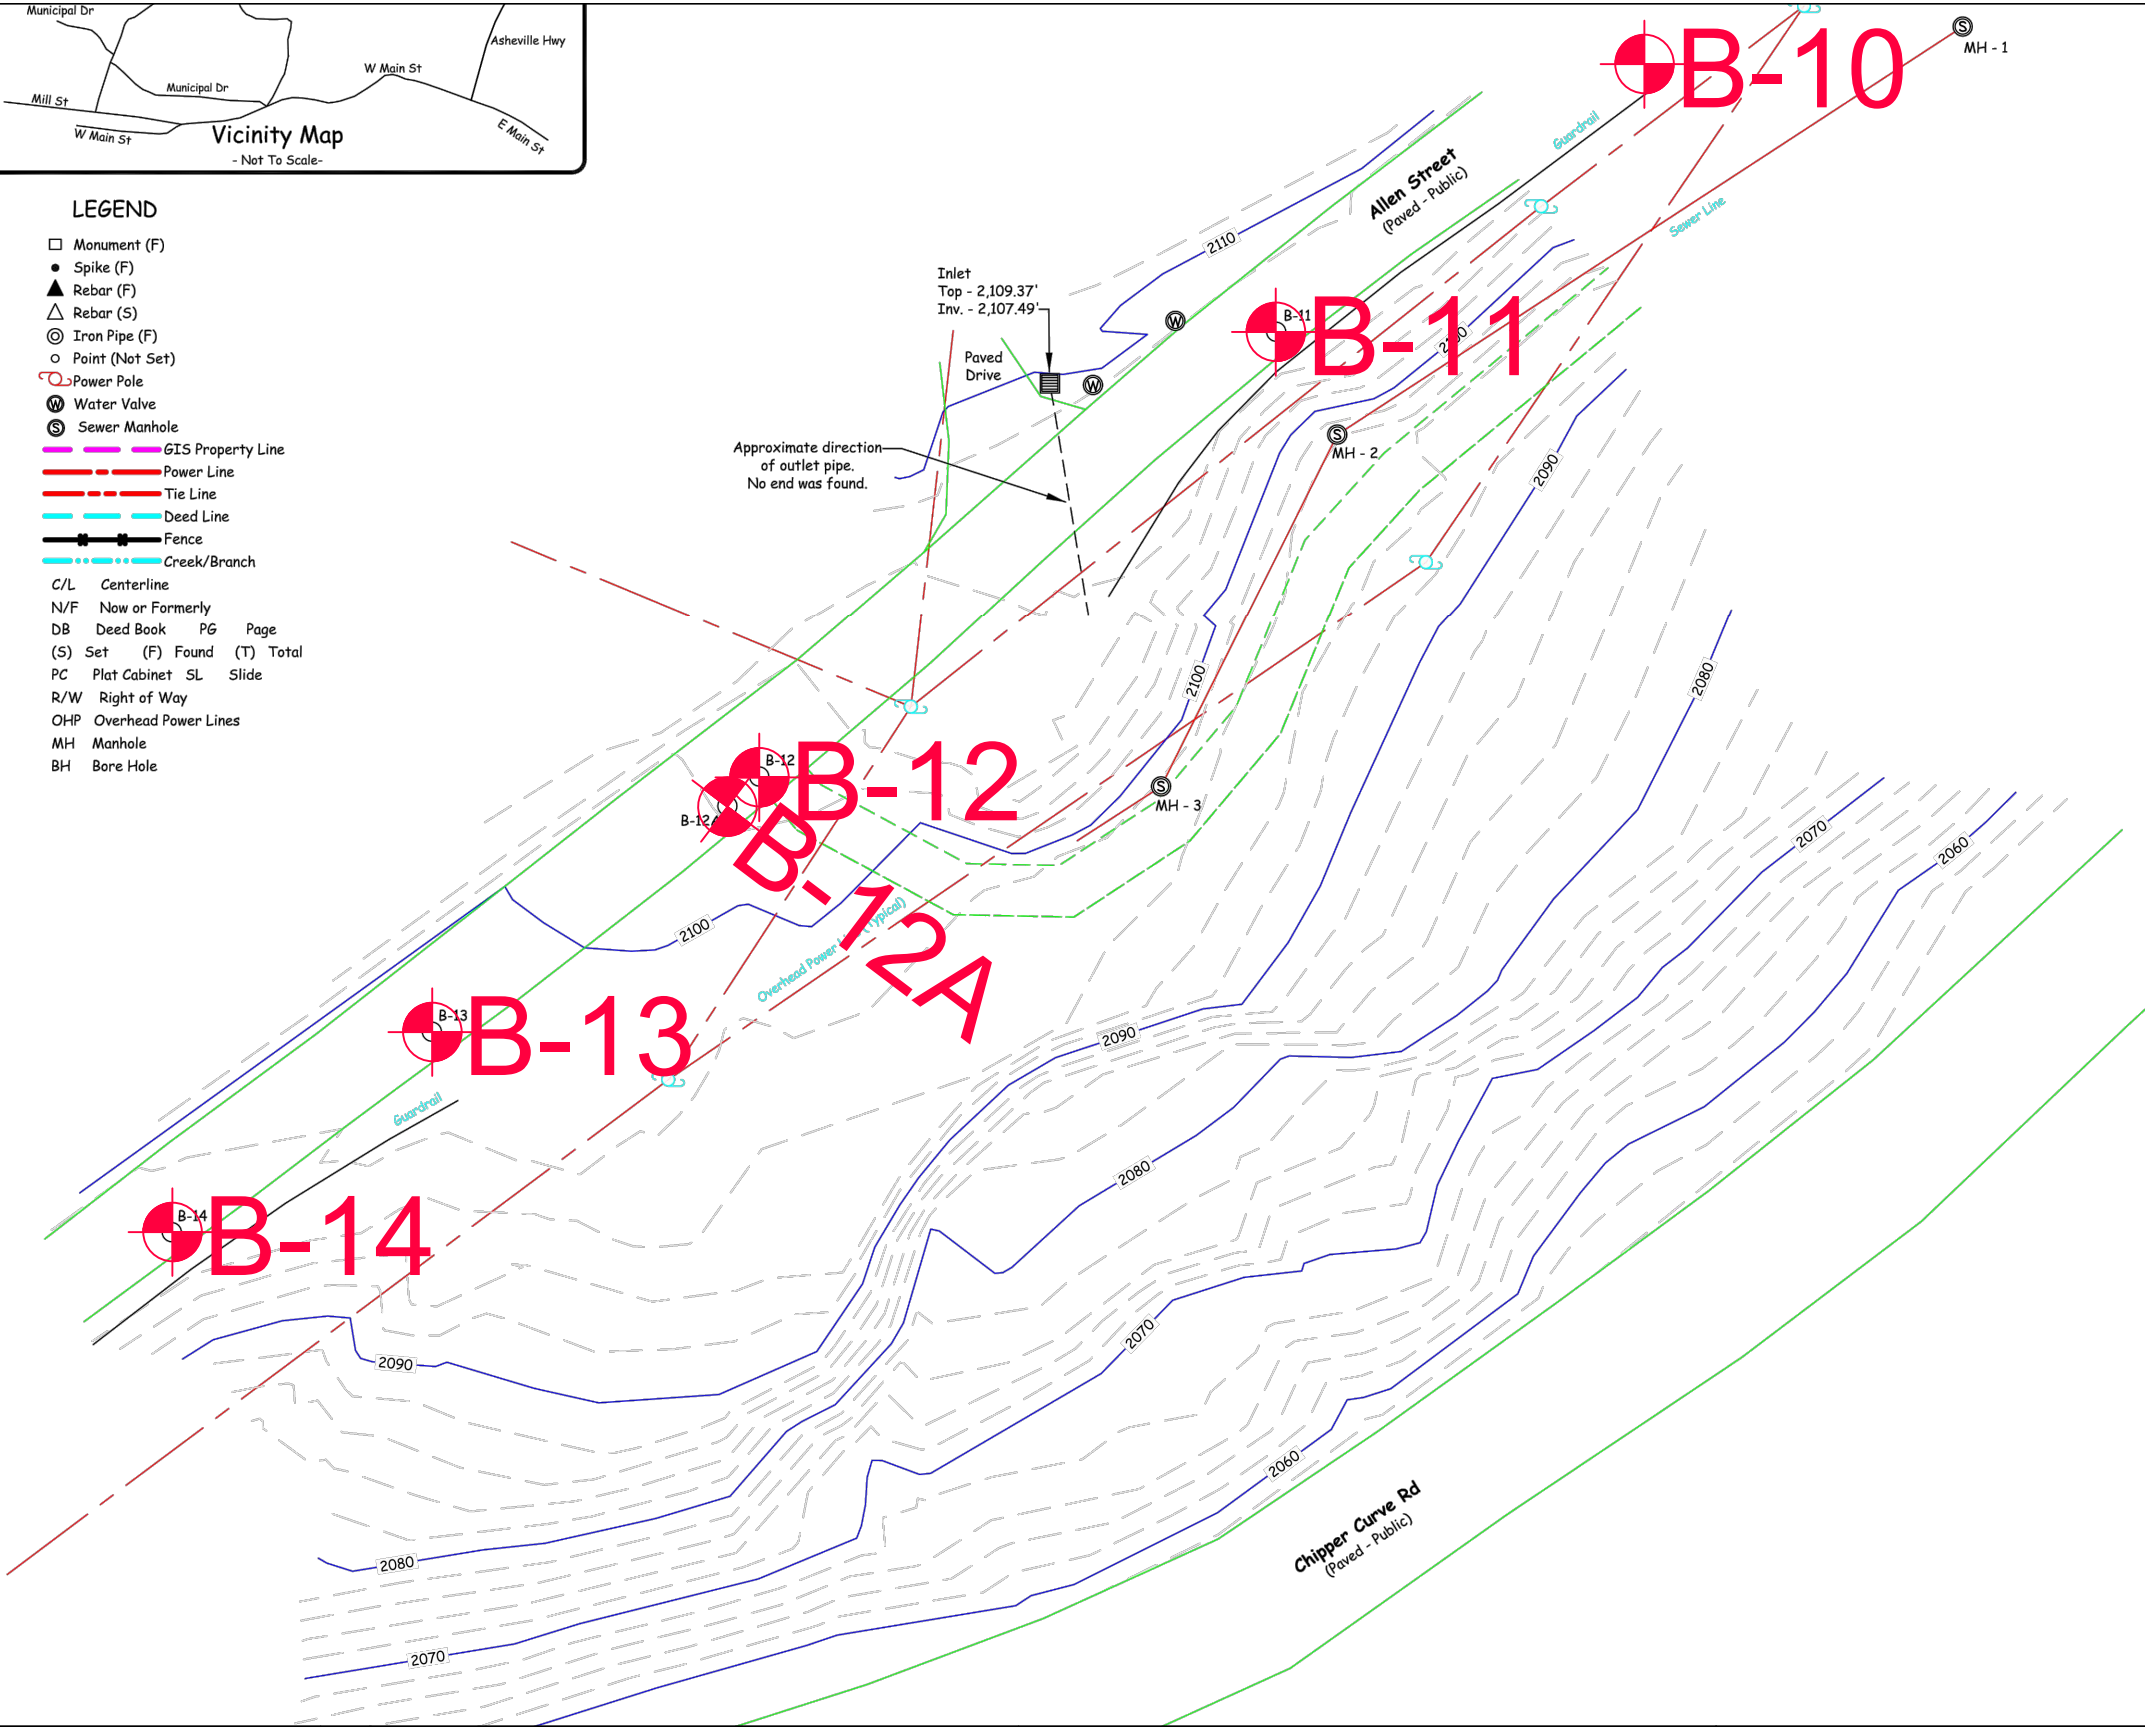
FIGURE
2

The site was explored by performing five (5) soil test borings (B-10 to B-14) at the approximate locations as indicated on the attached Field Exploration Plan (see Figure 2). Borings were located in the field by our Mr. Ian Johnson, P.E. Borings were located within Allen Street. Boring B-12 encountered shallow auger refusal and was offset as boring B-12A. Data from these borings was combined as boring B-12/12A.

FIELD EXPLORATION PLAN DATE: 03-19-2021
 REFERENCE: Topographic Survey prepared for: Town of Sylva, by Alliance Land Surveying, P.C., dated 01/20/2021.
 Note: Boring B-10 location estimated from field measurement by KEG. Other boring locations by surveyor.

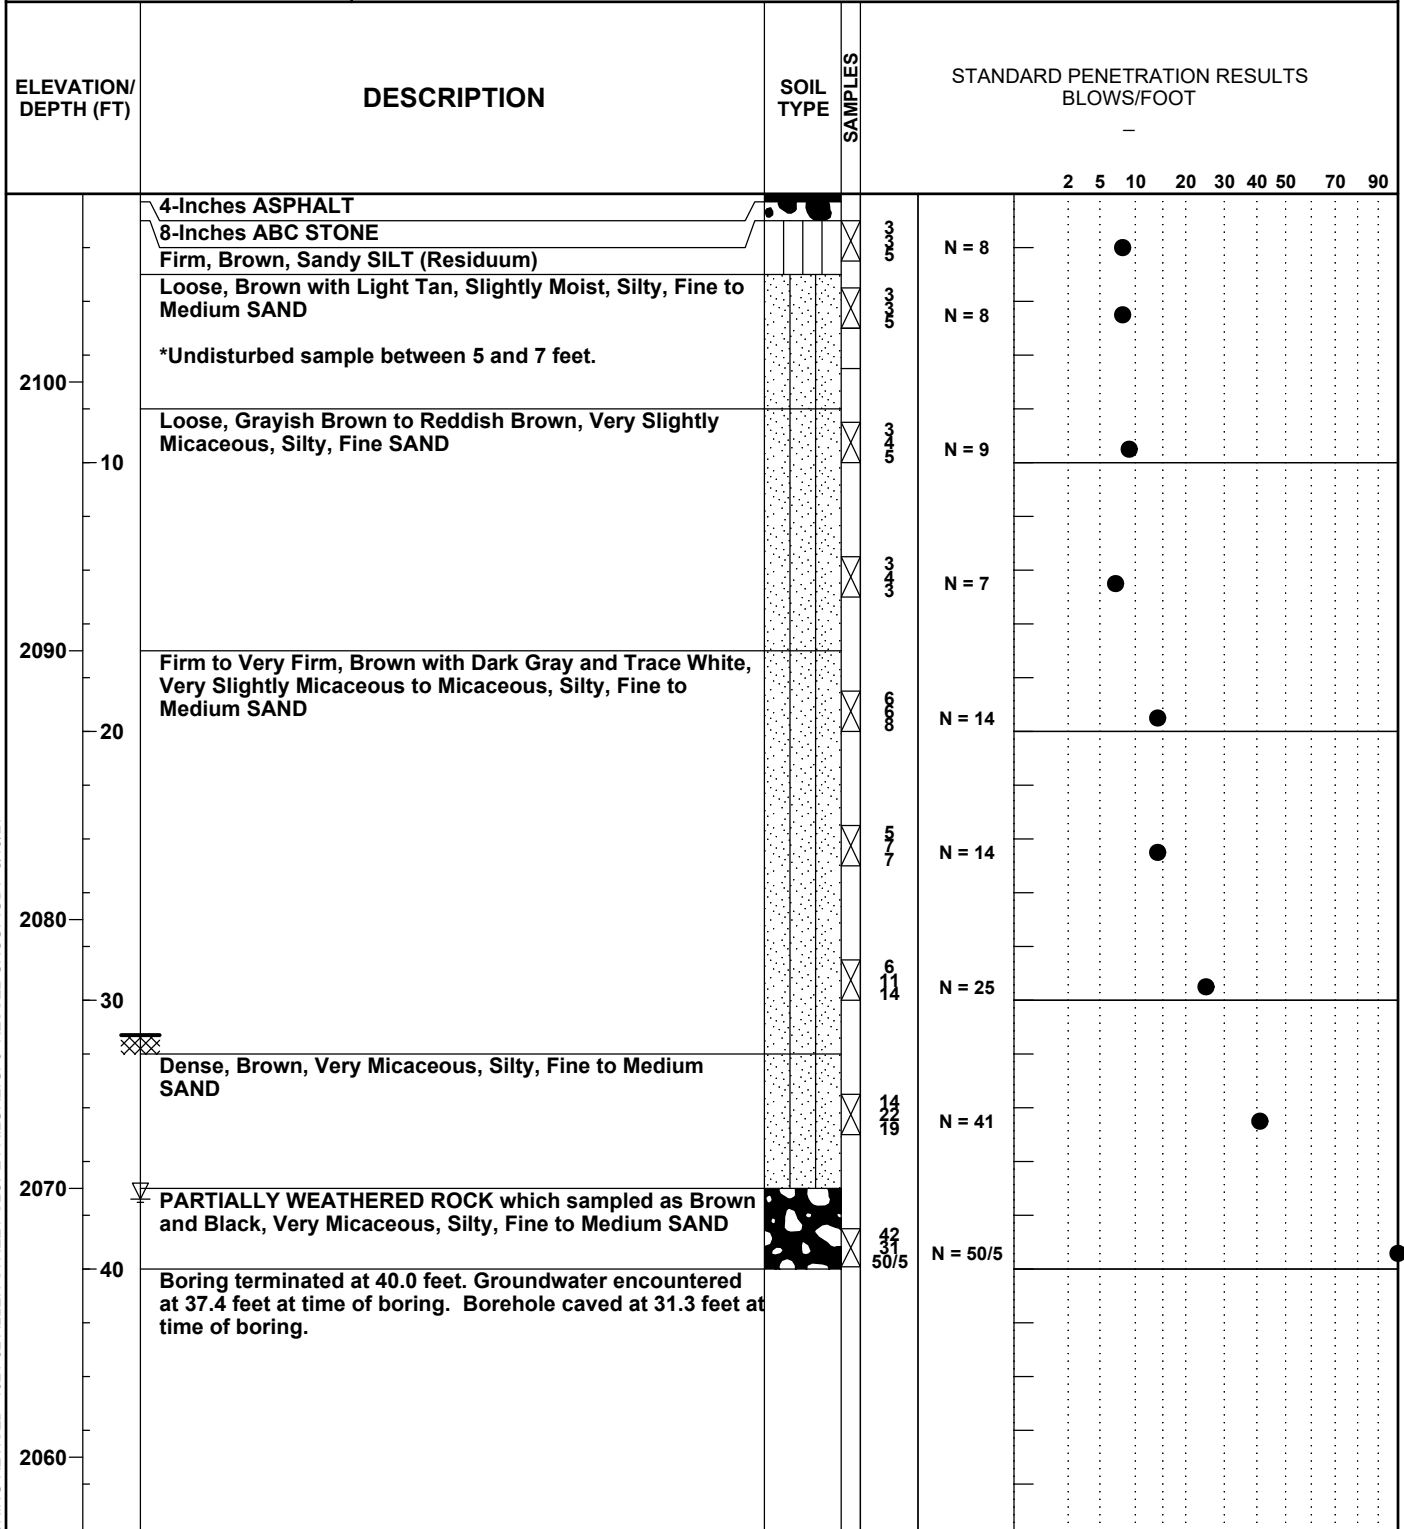
SOIL TEST BORING NO. B-10

PROJECT: Allen Street Slope Failure - S. Section PROJECT NO.: JA20-4021-02
 CLIENT: Town of Sylva DATE START: 12-7-20 END: 12-7-20
 LOCATION: See Figure 2 ELEVATION: 2107 (feet)
 DRILLER: M&M Drilling LOGGED BY: I. Johnson
 DRILLING METHOD: Hollow Stem Auger
 DEPTH TO - WATER> INITIAL ∇ 37.4 ft AFTER 24 HOURS: ∇ _____ CAVING> \otimes 31.3 ft

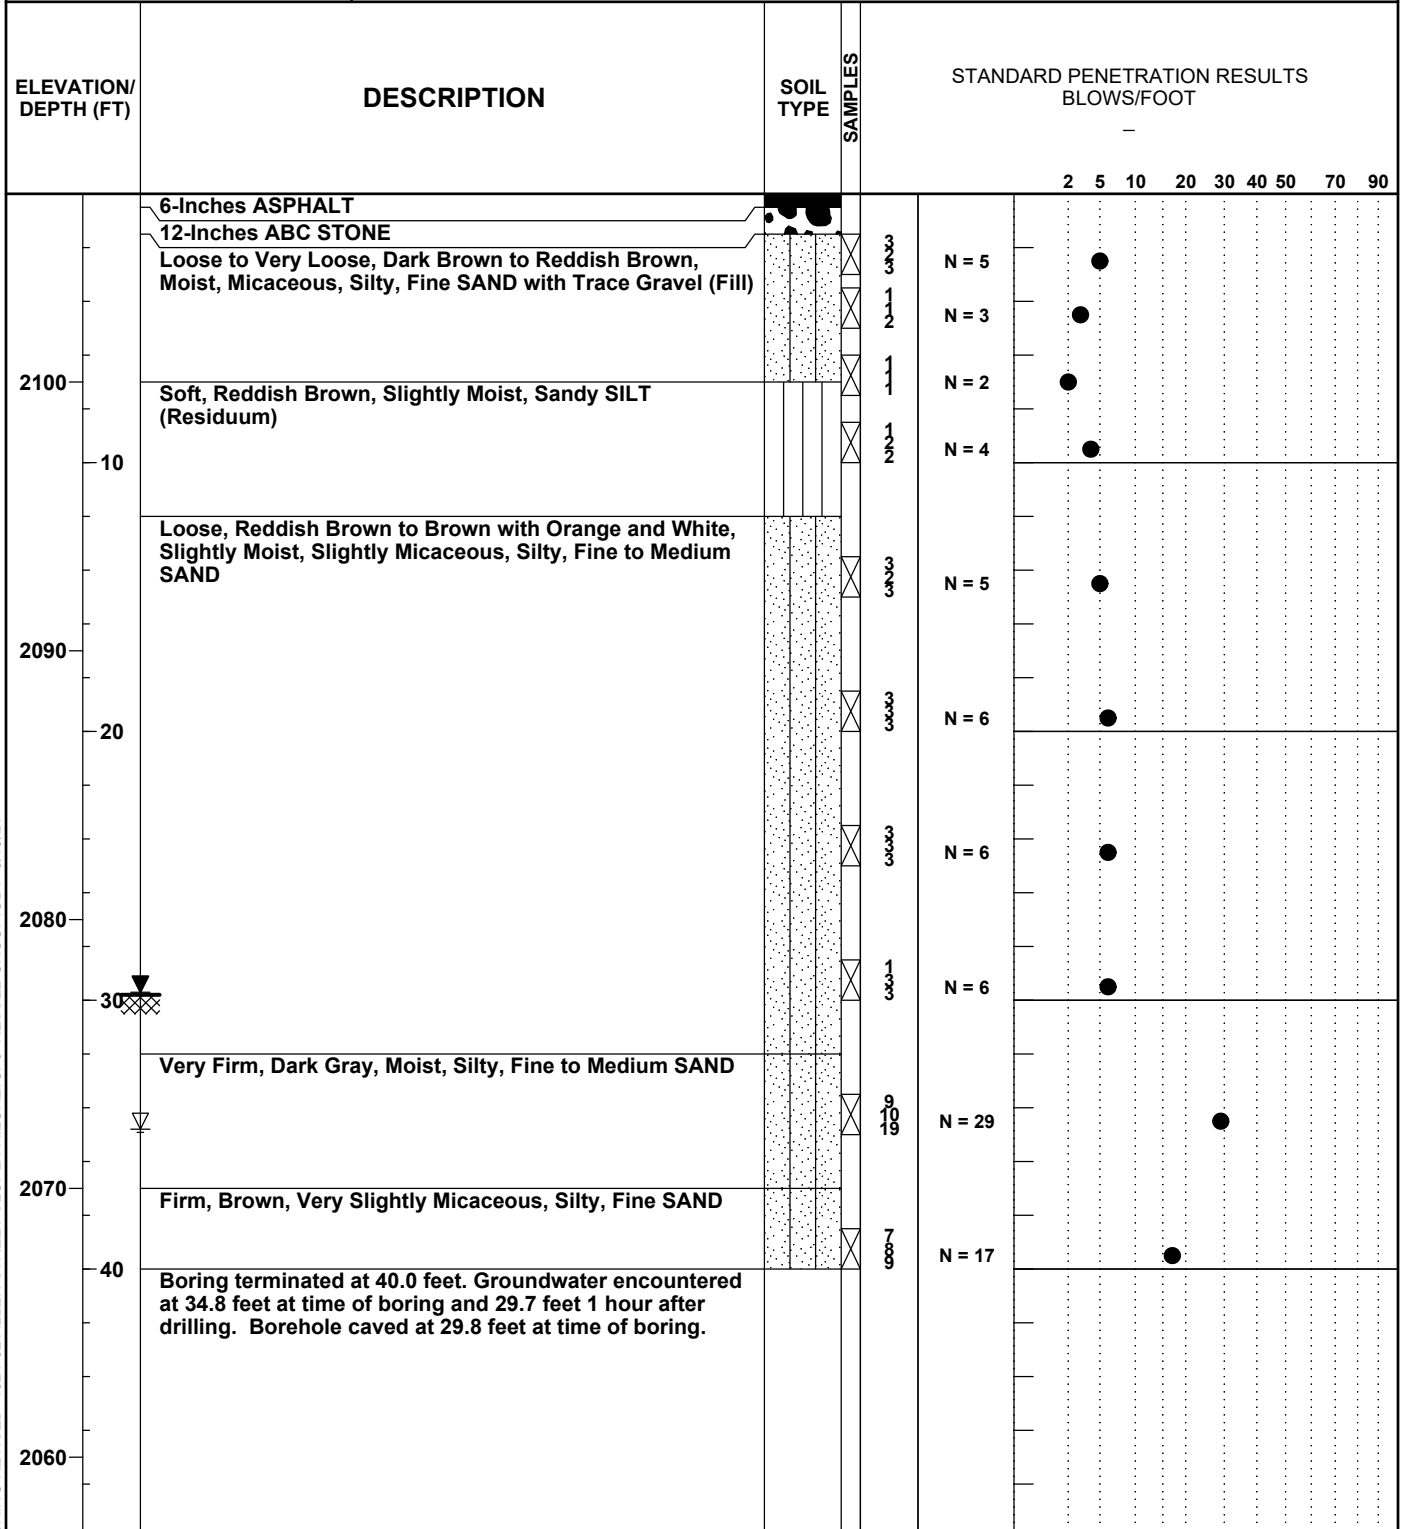
SOIL TEST BORING NO. B-11

PROJECT: Allen Street Slope Failure - S. Section PROJECT NO.: JA20-4021-02
 CLIENT: Town of Sylva DATE START: 12-8-20 END: 12-8-20
 LOCATION: See Figure 2 ELEVATION: 2107 (feet)
 DRILLER: M&M Drilling LOGGED BY: I. Johnson
 DRILLING METHOD: Hollow Stem Auger
 DEPTH TO - WATER> INITIAL ∇ 34.8 ft AFTER 1 HOURS: ∇ 29.7 ft CAVING ∇ 29.8 ft

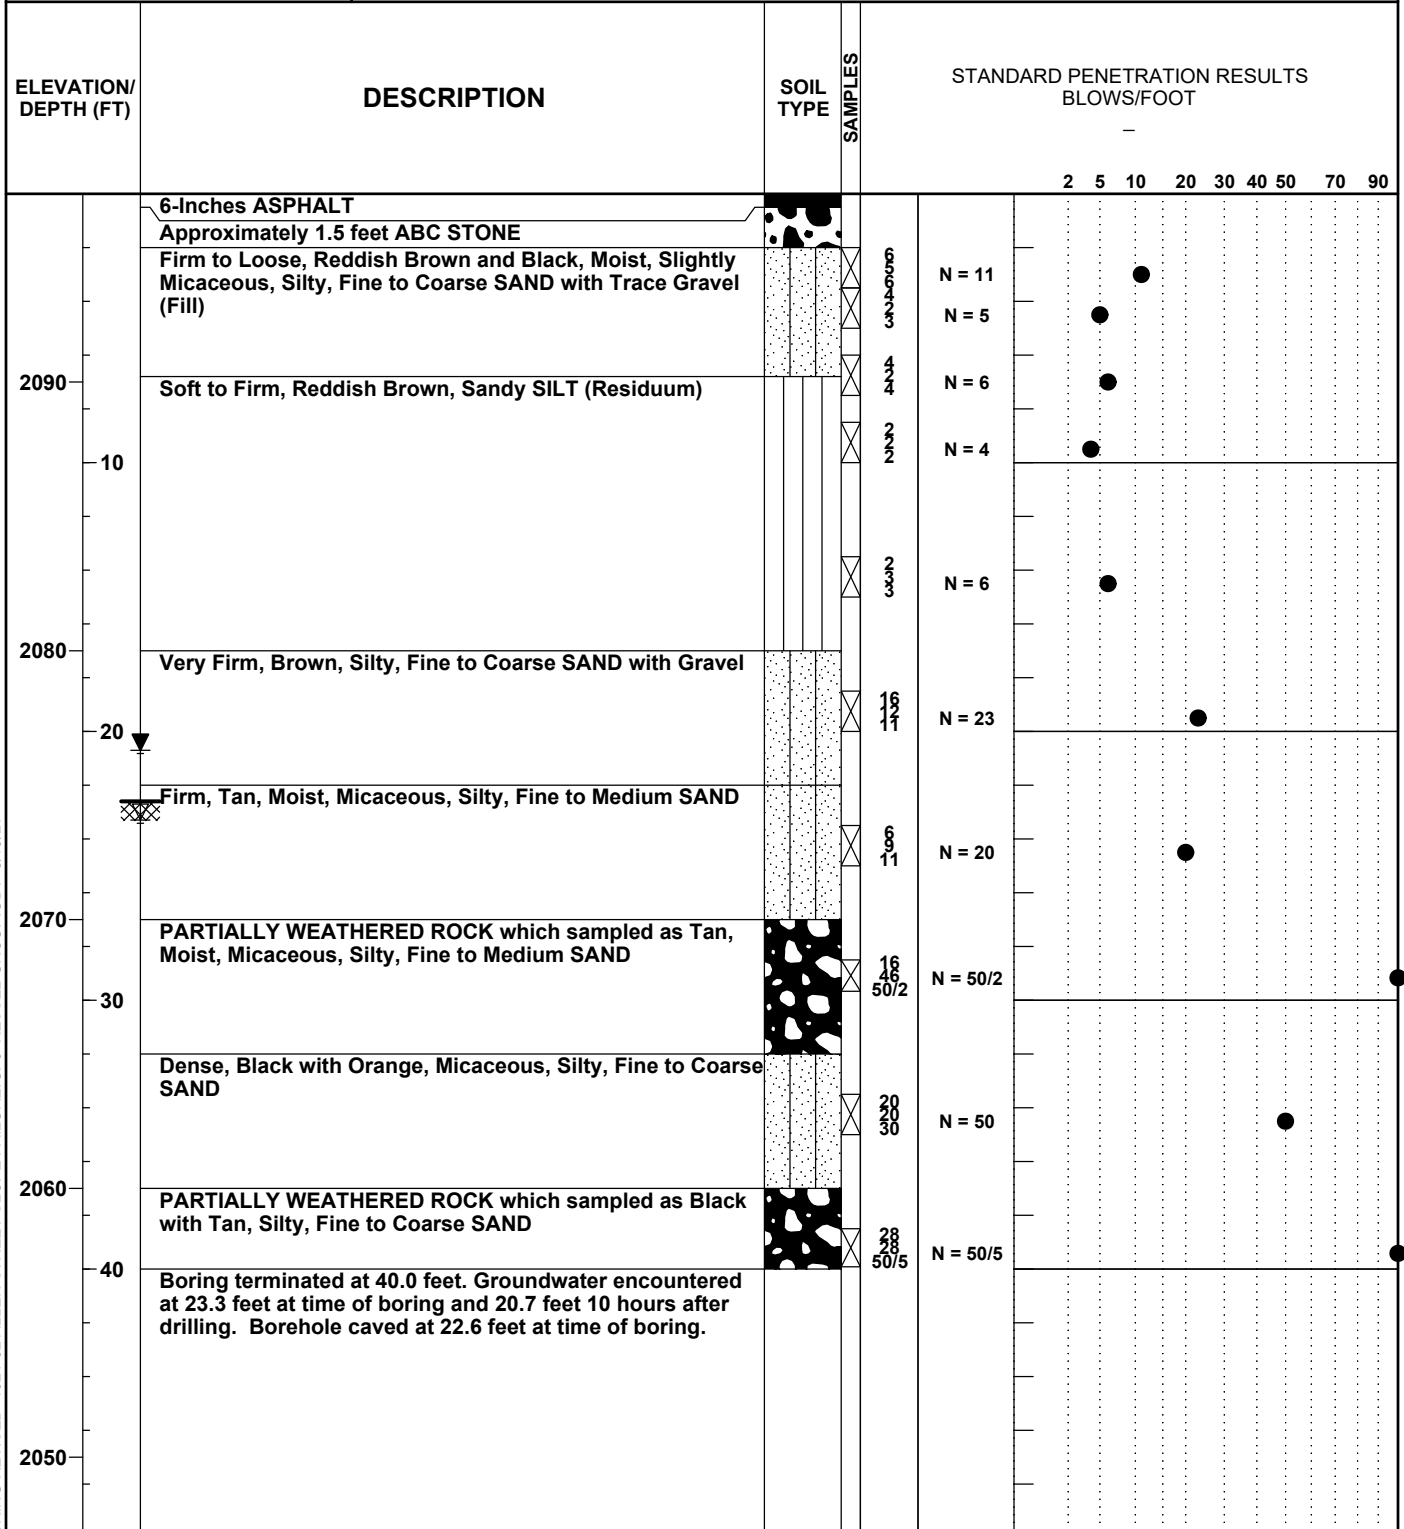
SOIL TEST BORING NO. B-14

PROJECT: Allen Street Slope Failure - S. Section PROJECT NO.: JA20-4021-02
 CLIENT: Town of Sylva DATE START: 12-7-20 END: 12-7-20
 LOCATION: See Figure 2 ELEVATION: 2097 (feet)
 DRILLER: M&M Drilling LOGGED BY: I. Johnson
 DRILLING METHOD: Hollow Stem Auger
 DEPTH TO - WATER> INITIAL 23.3 ft AFTER 10 HOURS: 20.7 ft CAVING 22.6 ft
