Field Report

Allen Street Slope Failures Sylva, North Carolina

November 2, 2020

North Carolina Geological Survey

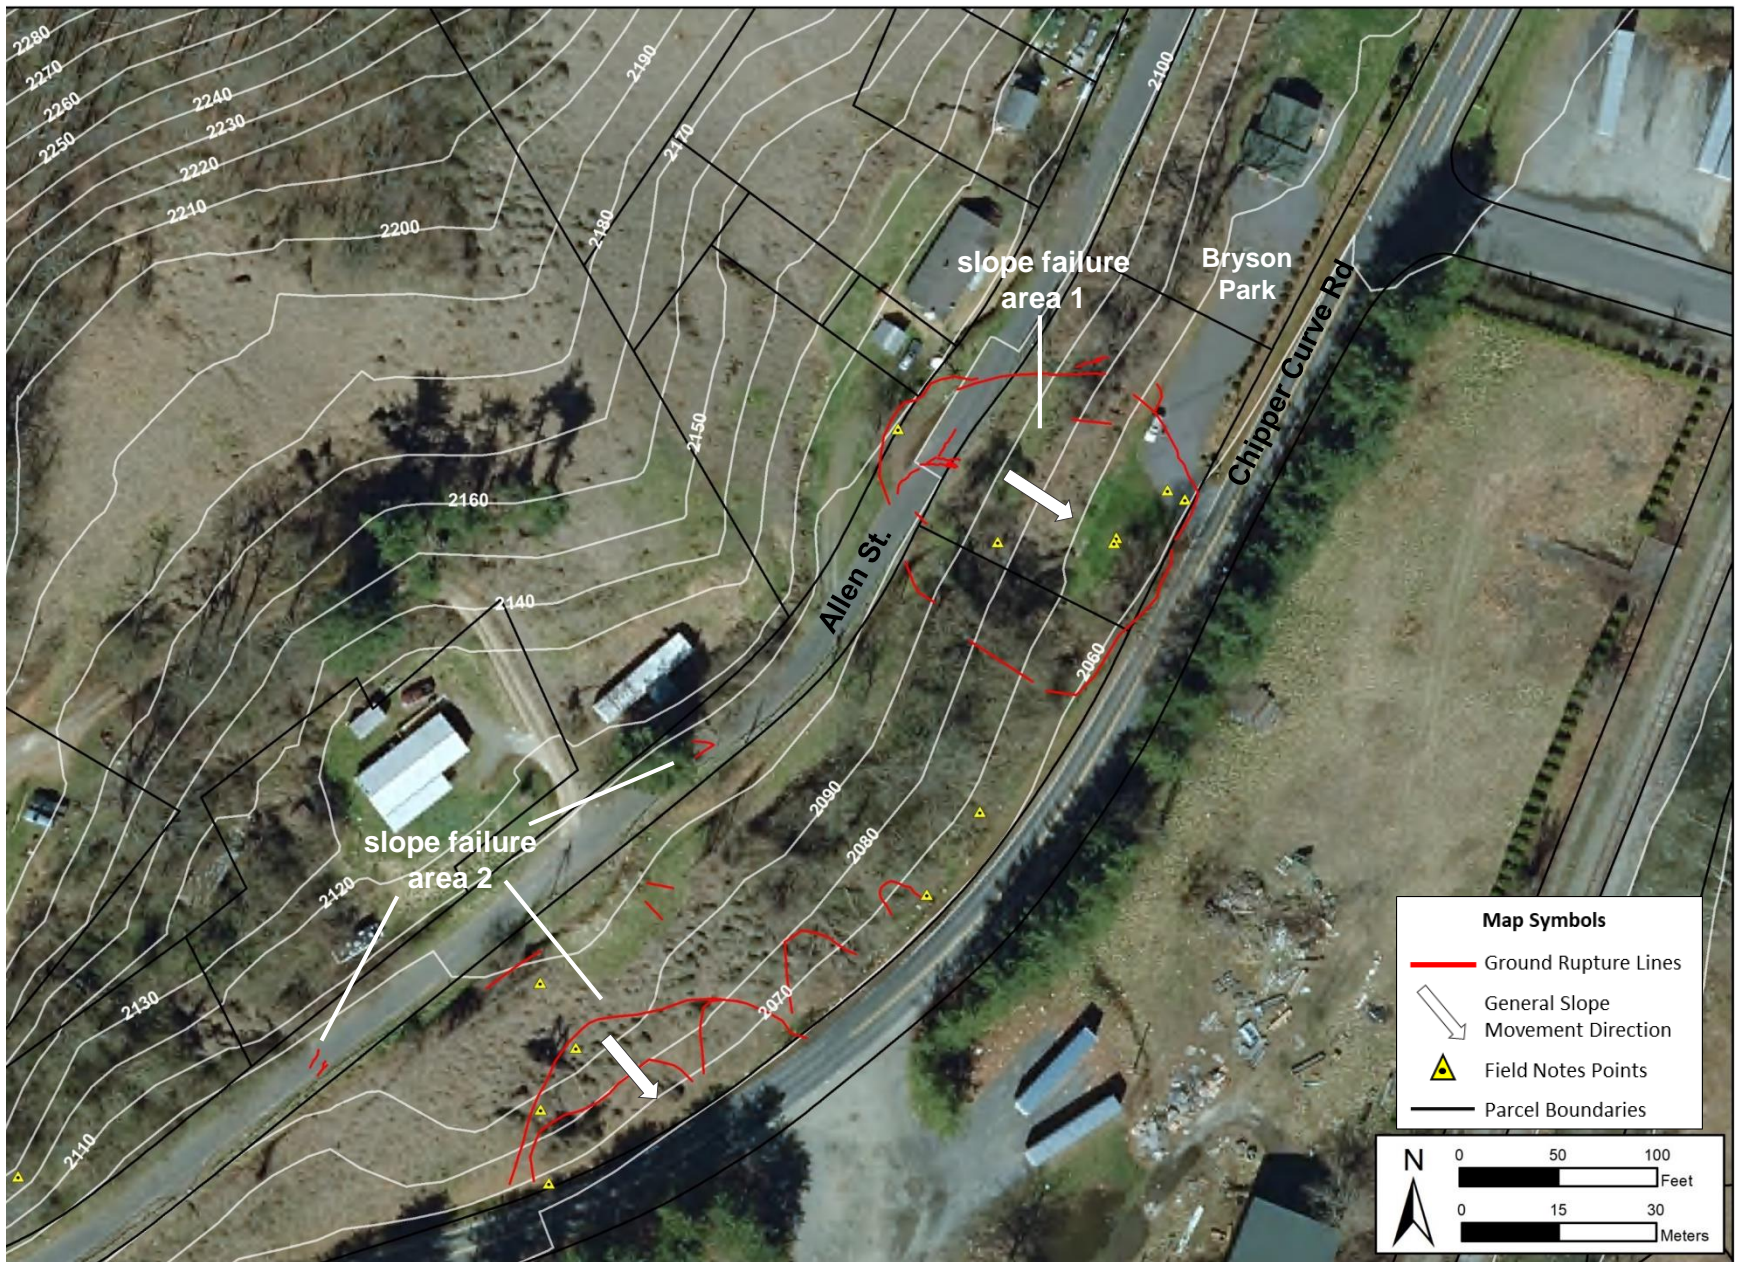
Figure 1. Map showing ground rupture lines (scarps) in slope failure areas 1 and 2. Field notes points are specific locations where data were collected on October 1 and 8, 2020. All locations are approximate. Map base is 2019 orthophotography and elevation contours are in feet.

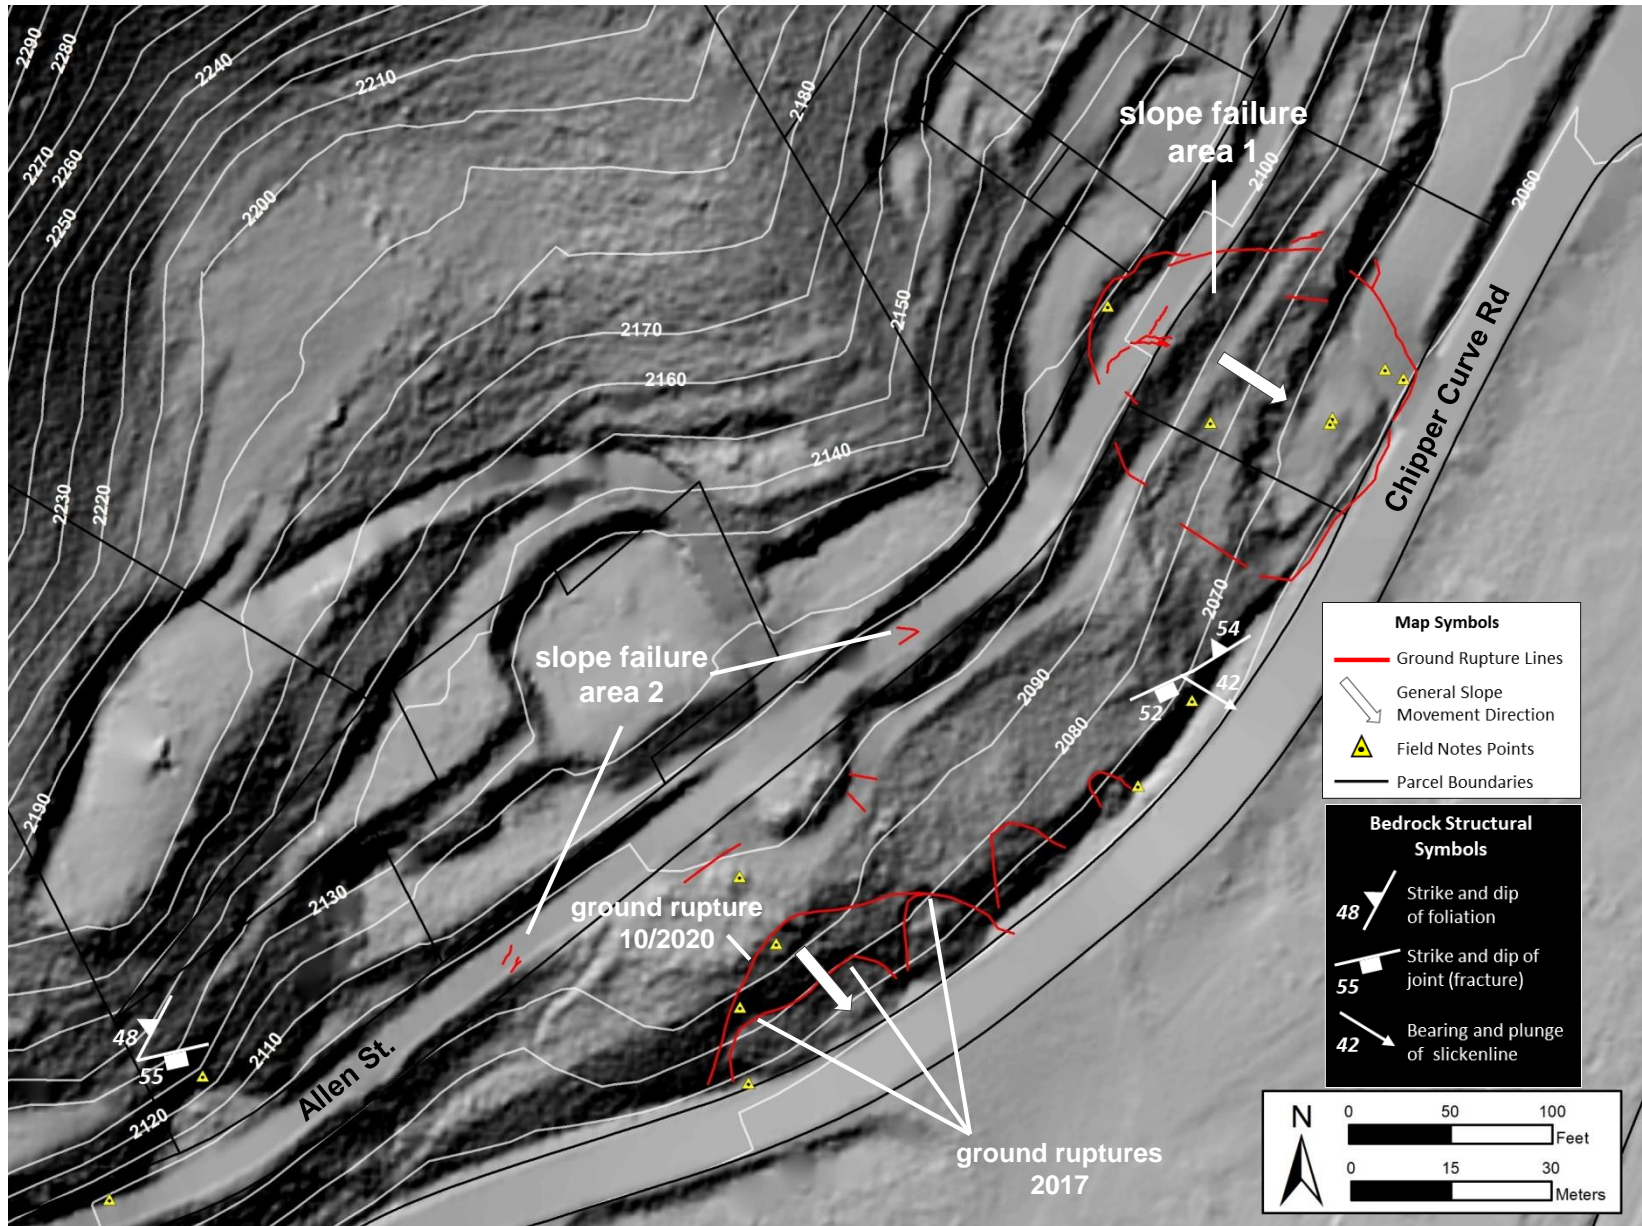
Figure 2. Map showing ground rupture lines (scarps) in slope failure areas 1 and 2. Note the upslope progression of the ground ruptures (scarps) from 2017 to 2020 above Chipper Curve Road. Field notes points are specific locations where data were collected on October 1 and 8, 2020. Bedrock structural symbols are adjacent to the outcrop location at the field note point. All locations are approximate. Map base is a shaded relief map derived from a sub-meter resolution 2017 lidar digital elevation model. Elevation contours are in feet.

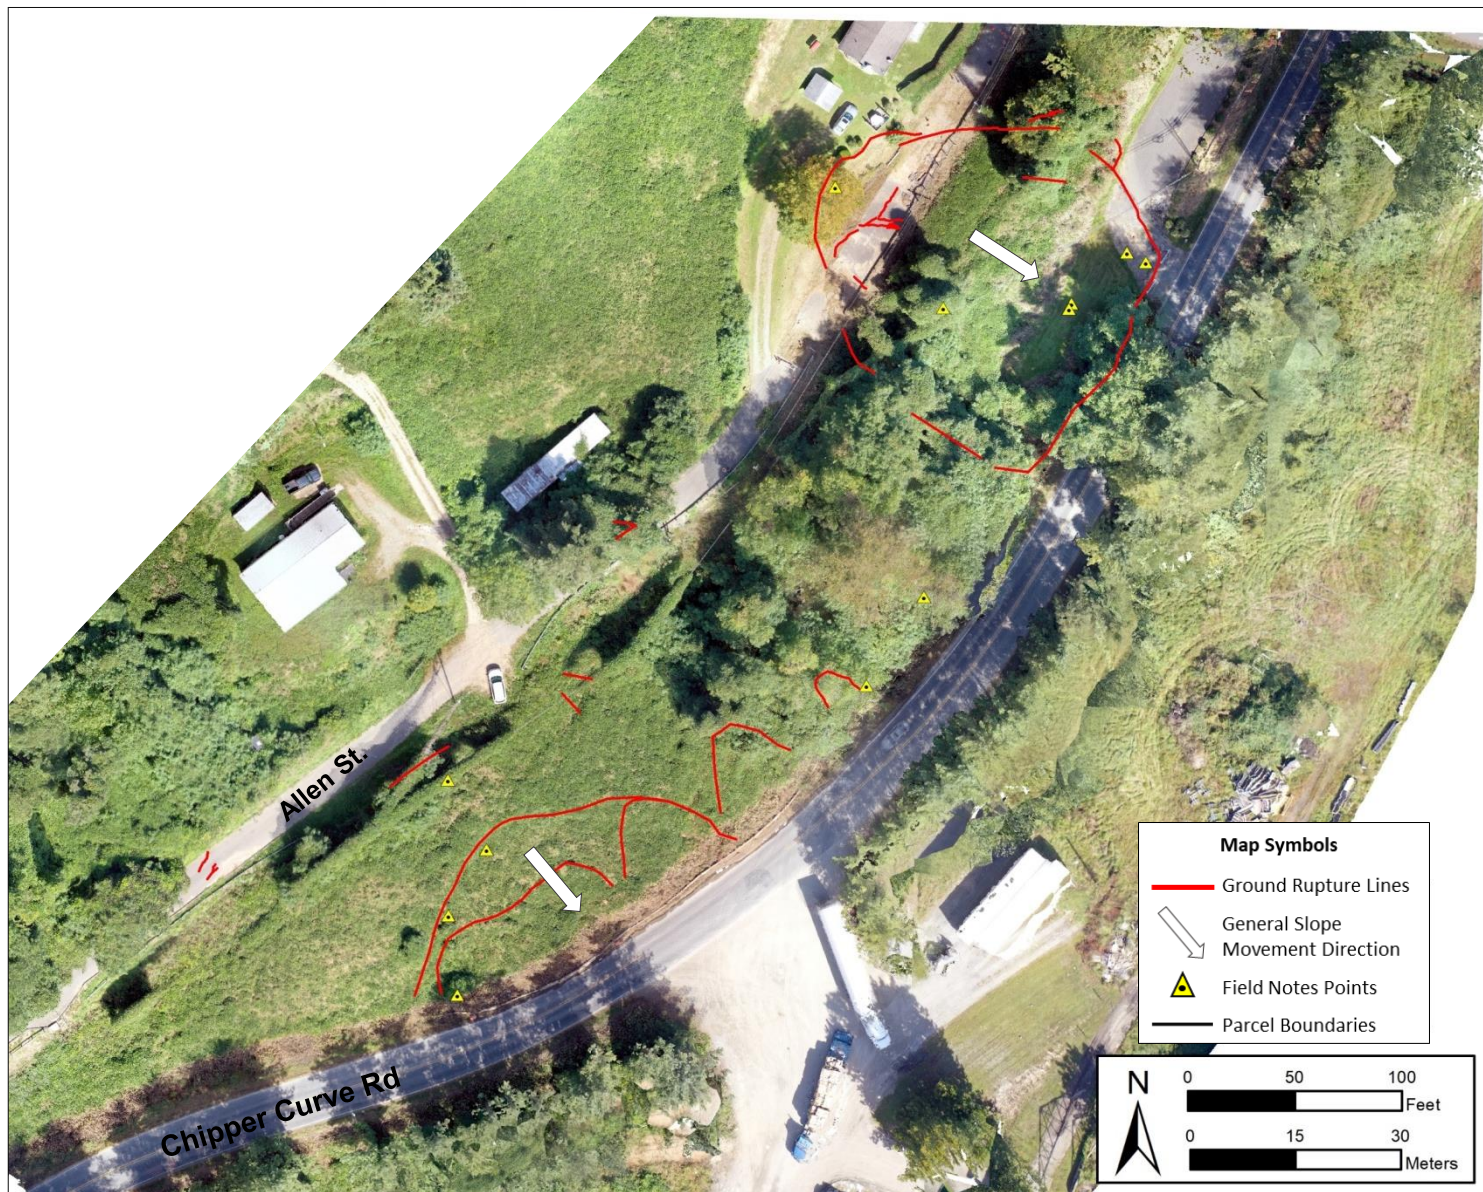
Figure 3. Map showing ground rupture lines (scarps) in slope failure areas 1 and 2. Field notes points are specific locations where data were collected on October 1 and 8, 2020. All locations are approximate. Map base is a 10/08/2020 UAS orthomosaic image.

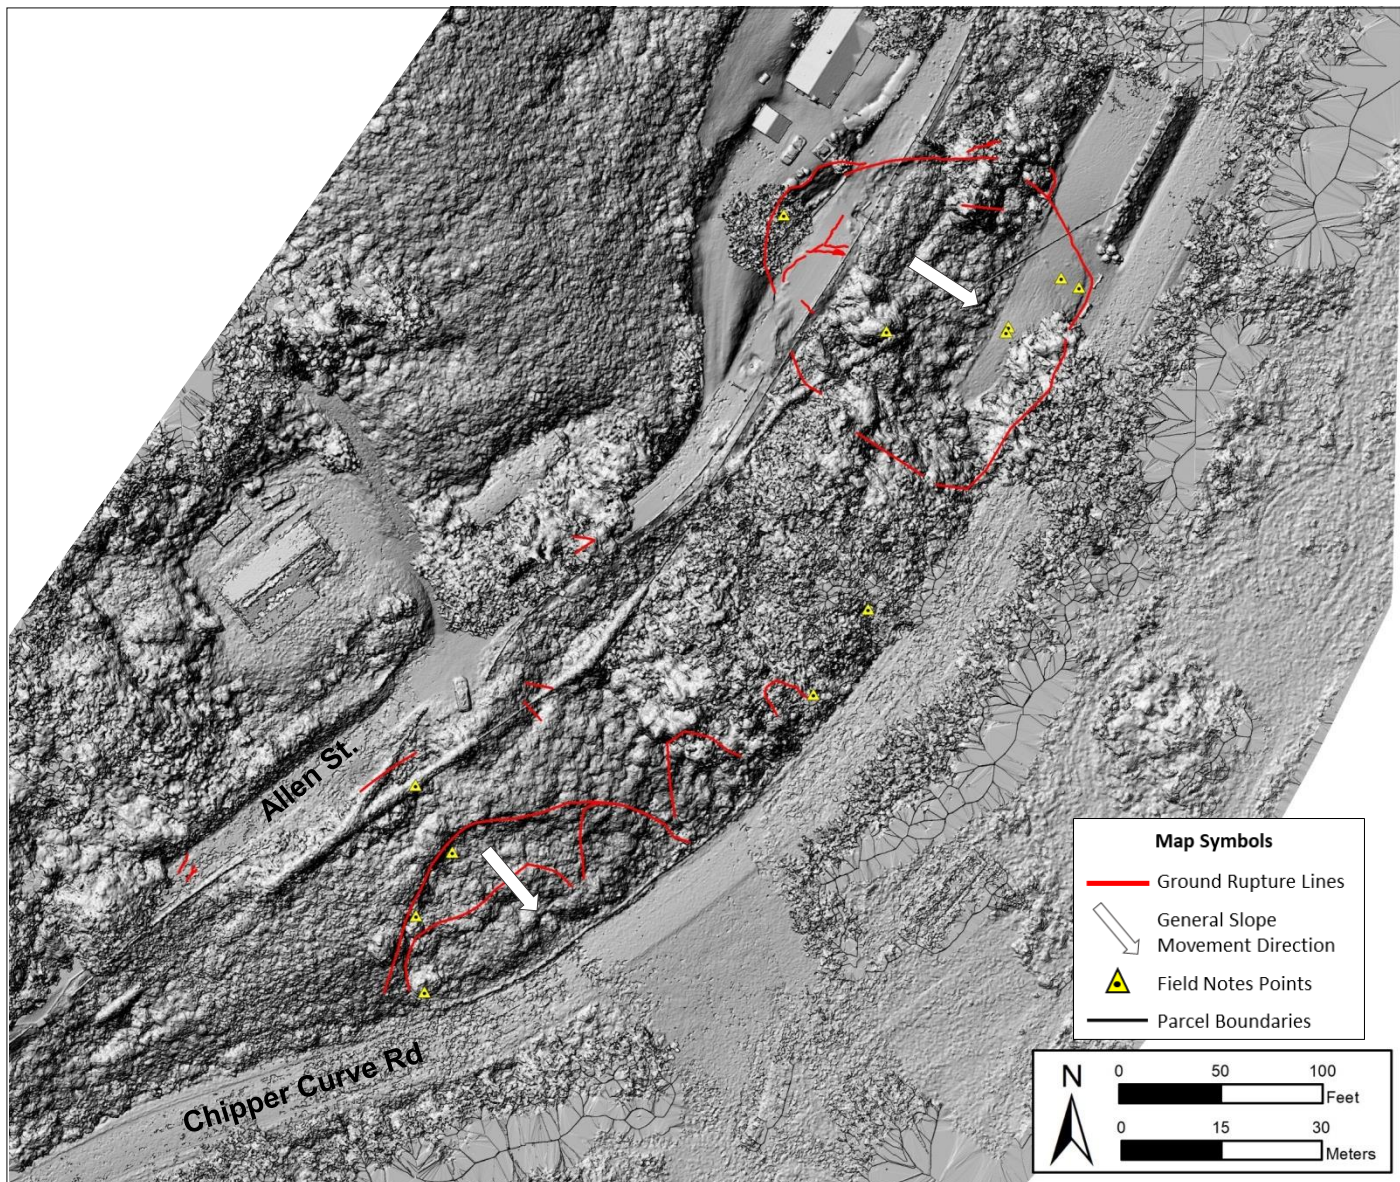
Figure 4. Map showing ground rupture lines (scarps) in slope failure areas 1 and 2. Field notes points are specific locations where data were collected on October 1 and 8, 2020. All locations are approximate. Map base is a digital surface model derived from 10/08/2020 UAS imagery. The vegetation surface is depicted in the image.

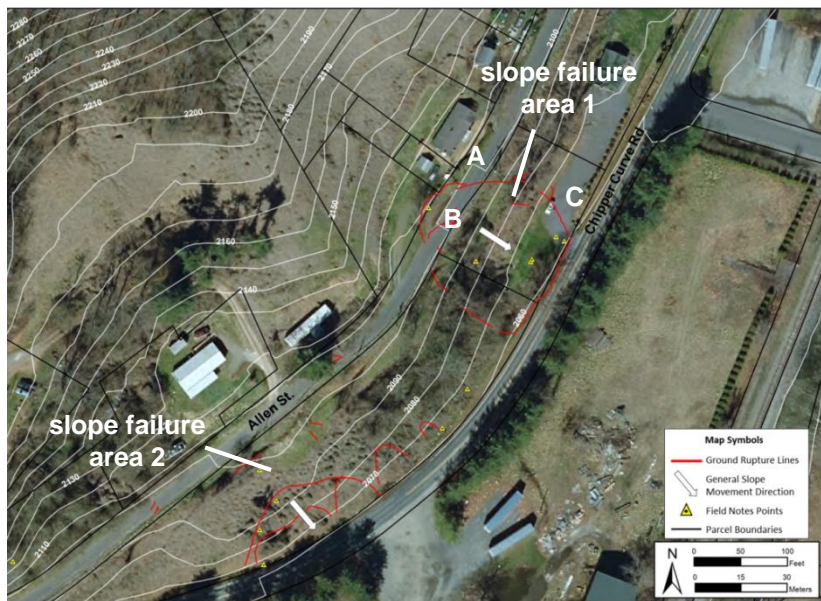
Our observations of the slide extent and characteristics, and geologic materials exposed at the surface are generally consistent with those presented in the KEG report (Kessel and Johnson, 2020). Figure 5 illustrates slide conditions as observed during our investigation. Figure 5A shows the down-dropped section of Allen Street, now barricaded. The upper portion of the main slide scarp extends into private property at 527 Allen Street (Fig. 5B) and threatens the driveway. Bulging, buckling, and deterioration of the pavement at the Bryson Park entrance (Fig. 5C) appears to have progressed somewhat from that shown in the KEG report. In summary, the areal extent of slide activity and the relative amounts of displacement we observed do not appear to be greatly different than those described in the KEG report.

Figure 5. Map showing ground rupture lines in slope failure areas 1 and 2 (see also Fig. 1). Map base is 2019 orthophotography. Locations A-C refer to photos.

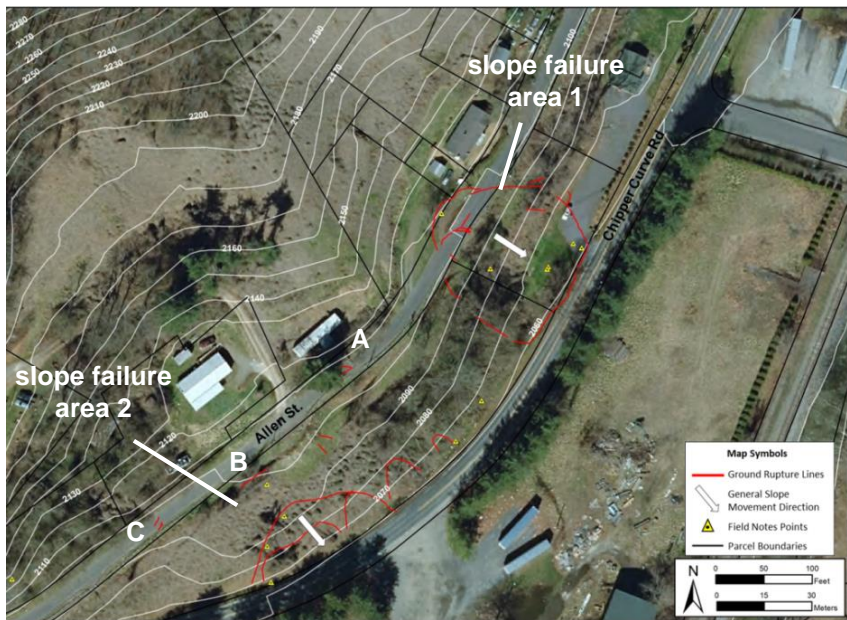
apart, and indicate initial stages of slope movement along this segment of Allen Street (Figs. 6A, C). We observed a ground rupture approximately 30-ft long, oriented SW-NE, in a vegetated slope approximately 15ft southeast of Allen Street (Fig. 6B) between the two areas of cracked pavement. The direction of slope movement indicated by these ground ruptures is generally toward the southeast. The TWSA has taken precautionary measures in anticipation of water and sewer line breaks in this section of the Allen Street corridor.

Figure 6. Map showing ground rupture lines in slope failure areas 1 and 2 (see also Fig. 1). Map base is 2019 orthophotography. Locations A-C refer to photos.

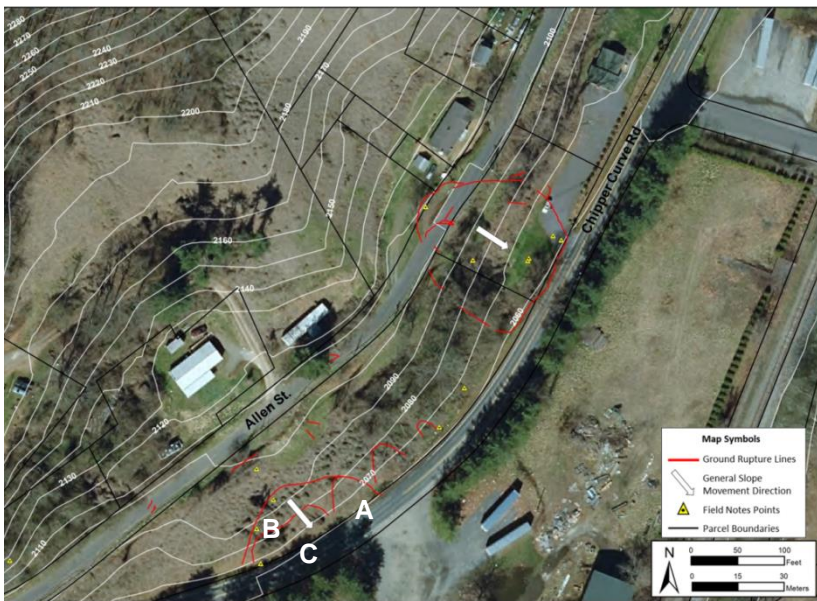
The active slide area along Chipper Curve Road is mitigated by concrete median barriers placed at the toe of the slope by NCDOT (Figs. 7A-C). Loose, wet soil has impinged on the barriers and resulted in some tipping of the barriers (Fig. 7C). A recent slide scarp is exposed midway up the kudzu-covered slope with as much as 10ft of vertical displacement (Fig. 7B,C). Completely decomposed bedrock (saprolite) is exposed in the scarp, consistent with other observations of residual soil derived from weathered bedrock in the area. Evidence indicates that this active slide area may have enlarged since 2017 with the main scarp migrating toward the northwest. Ground ruptures (scarps) and displaced soil are visible in the 2017 lidar digital elevation model for this area (Fig. 2). These coalescing slide areas predate the larger scarp observed in our ground investigations (Figs. 2 and 7B, C) and UAS imagery (Figs. 3 and 4), which is not visible in the 2017 lidar.

Figure 7. Map showing ground rupture lines in slope failure areas 1 and 2 (see also Fig. 1). Map base is 2019 orthophotography. Locations A-C refer to photos.
